Technical Service Bulletin

No. 71-8-16

Alternator
Pivot Bolt
Failure

MODELS: All
383 & 440 Cu.In.
Engines without
Air Conditioning
(Except Chrysler
& Plymouth Fury
with 383 Cu.In.
Engine)

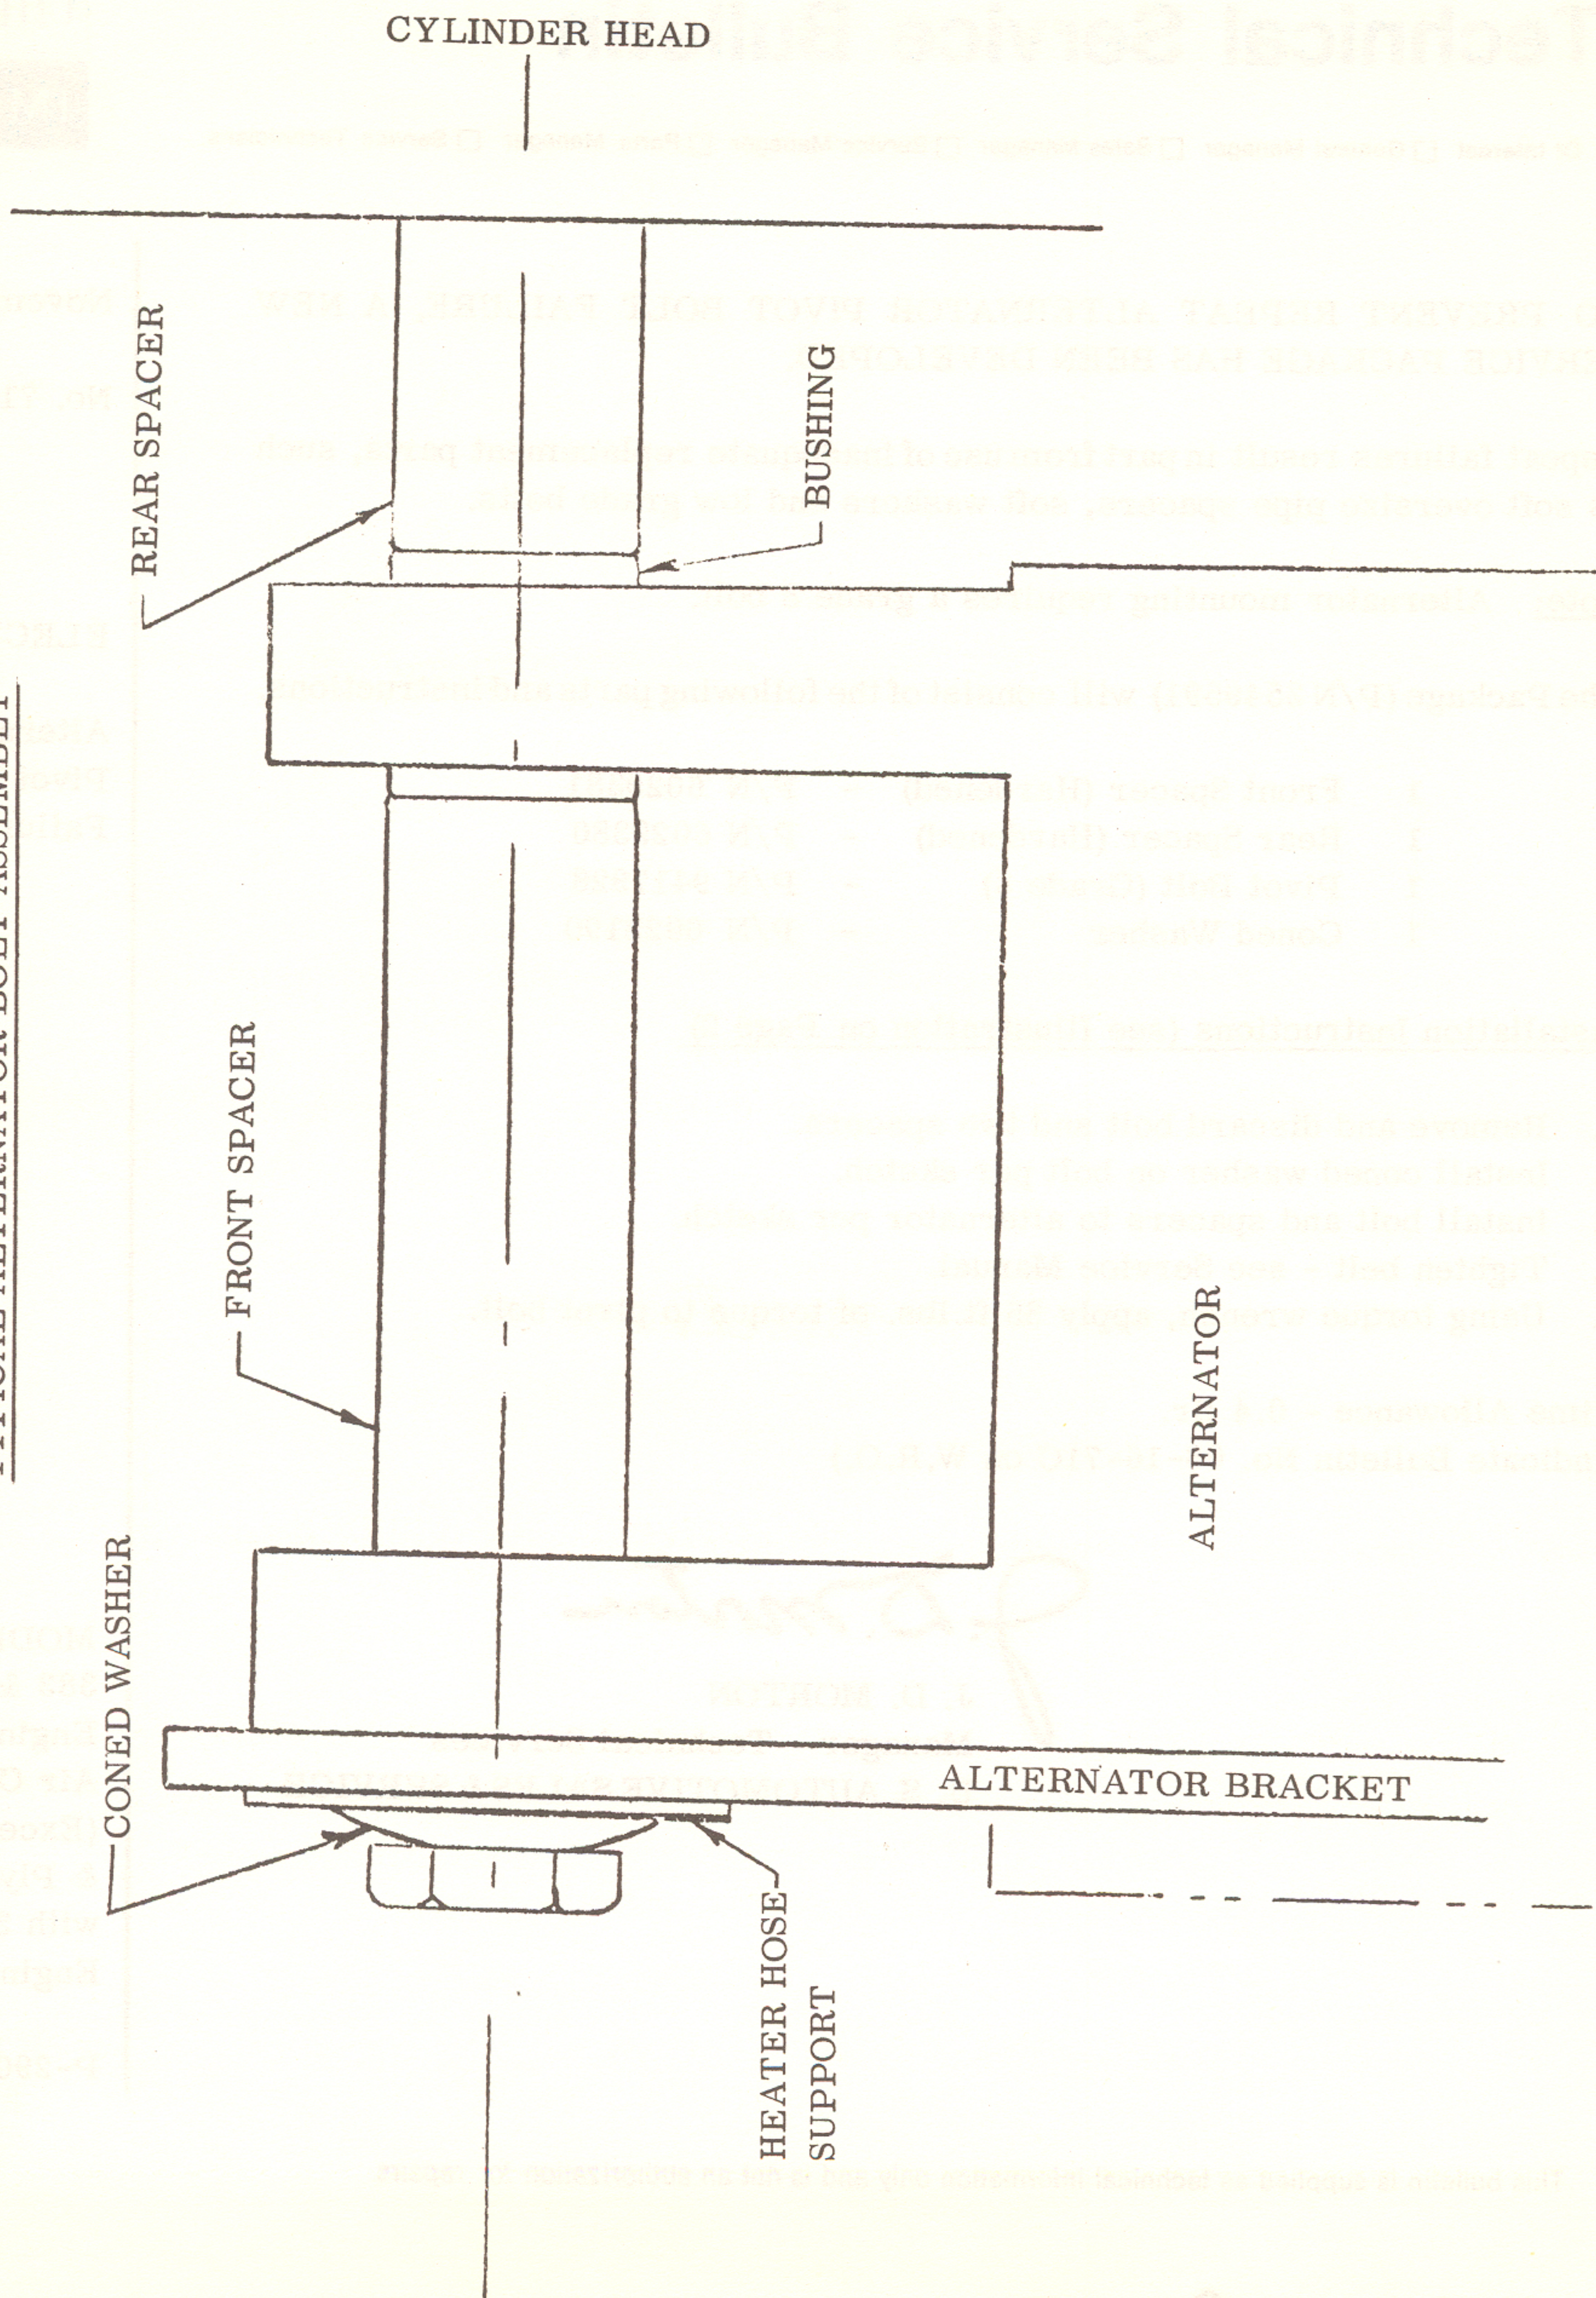
TYPICAL ALTERNATOR BOLT ASSEMBLY

TO PREVENT REPEAT ALTERNATOR PIVOT BOLT FAILURE, A NEW SERVICE PACKAGE HAS BEEN DEVELOPED.

Repeat failures result in part from use of inadequate replacement parts, such as soft oversize pipe spacers, soft washers and low grade bolts.

Note: Alternator mounting requires a grade 8 bolt.

Installation Instructions (see Illustration on Page 2)

1. Remove and discard bolt and two spacers.
2. Install coned washer on bolt per sketch.
3. Install bolt and spacers to alternator per sketch.
4. Tighten belt - see Service Manual.
5. Using torque wrench, apply 35 ft.lbs. of torque to pivot bolt.
