Technical Service Bulletin

No. D71-14-2

Engine Surge
and Stumble
Caused By
Warped
Air Horn

MODELS: 1968,
1969, 1970
and 1971
Models Equipped
With 383-2 bbl.
Engines and
1-1/2" BBD
Carburetors

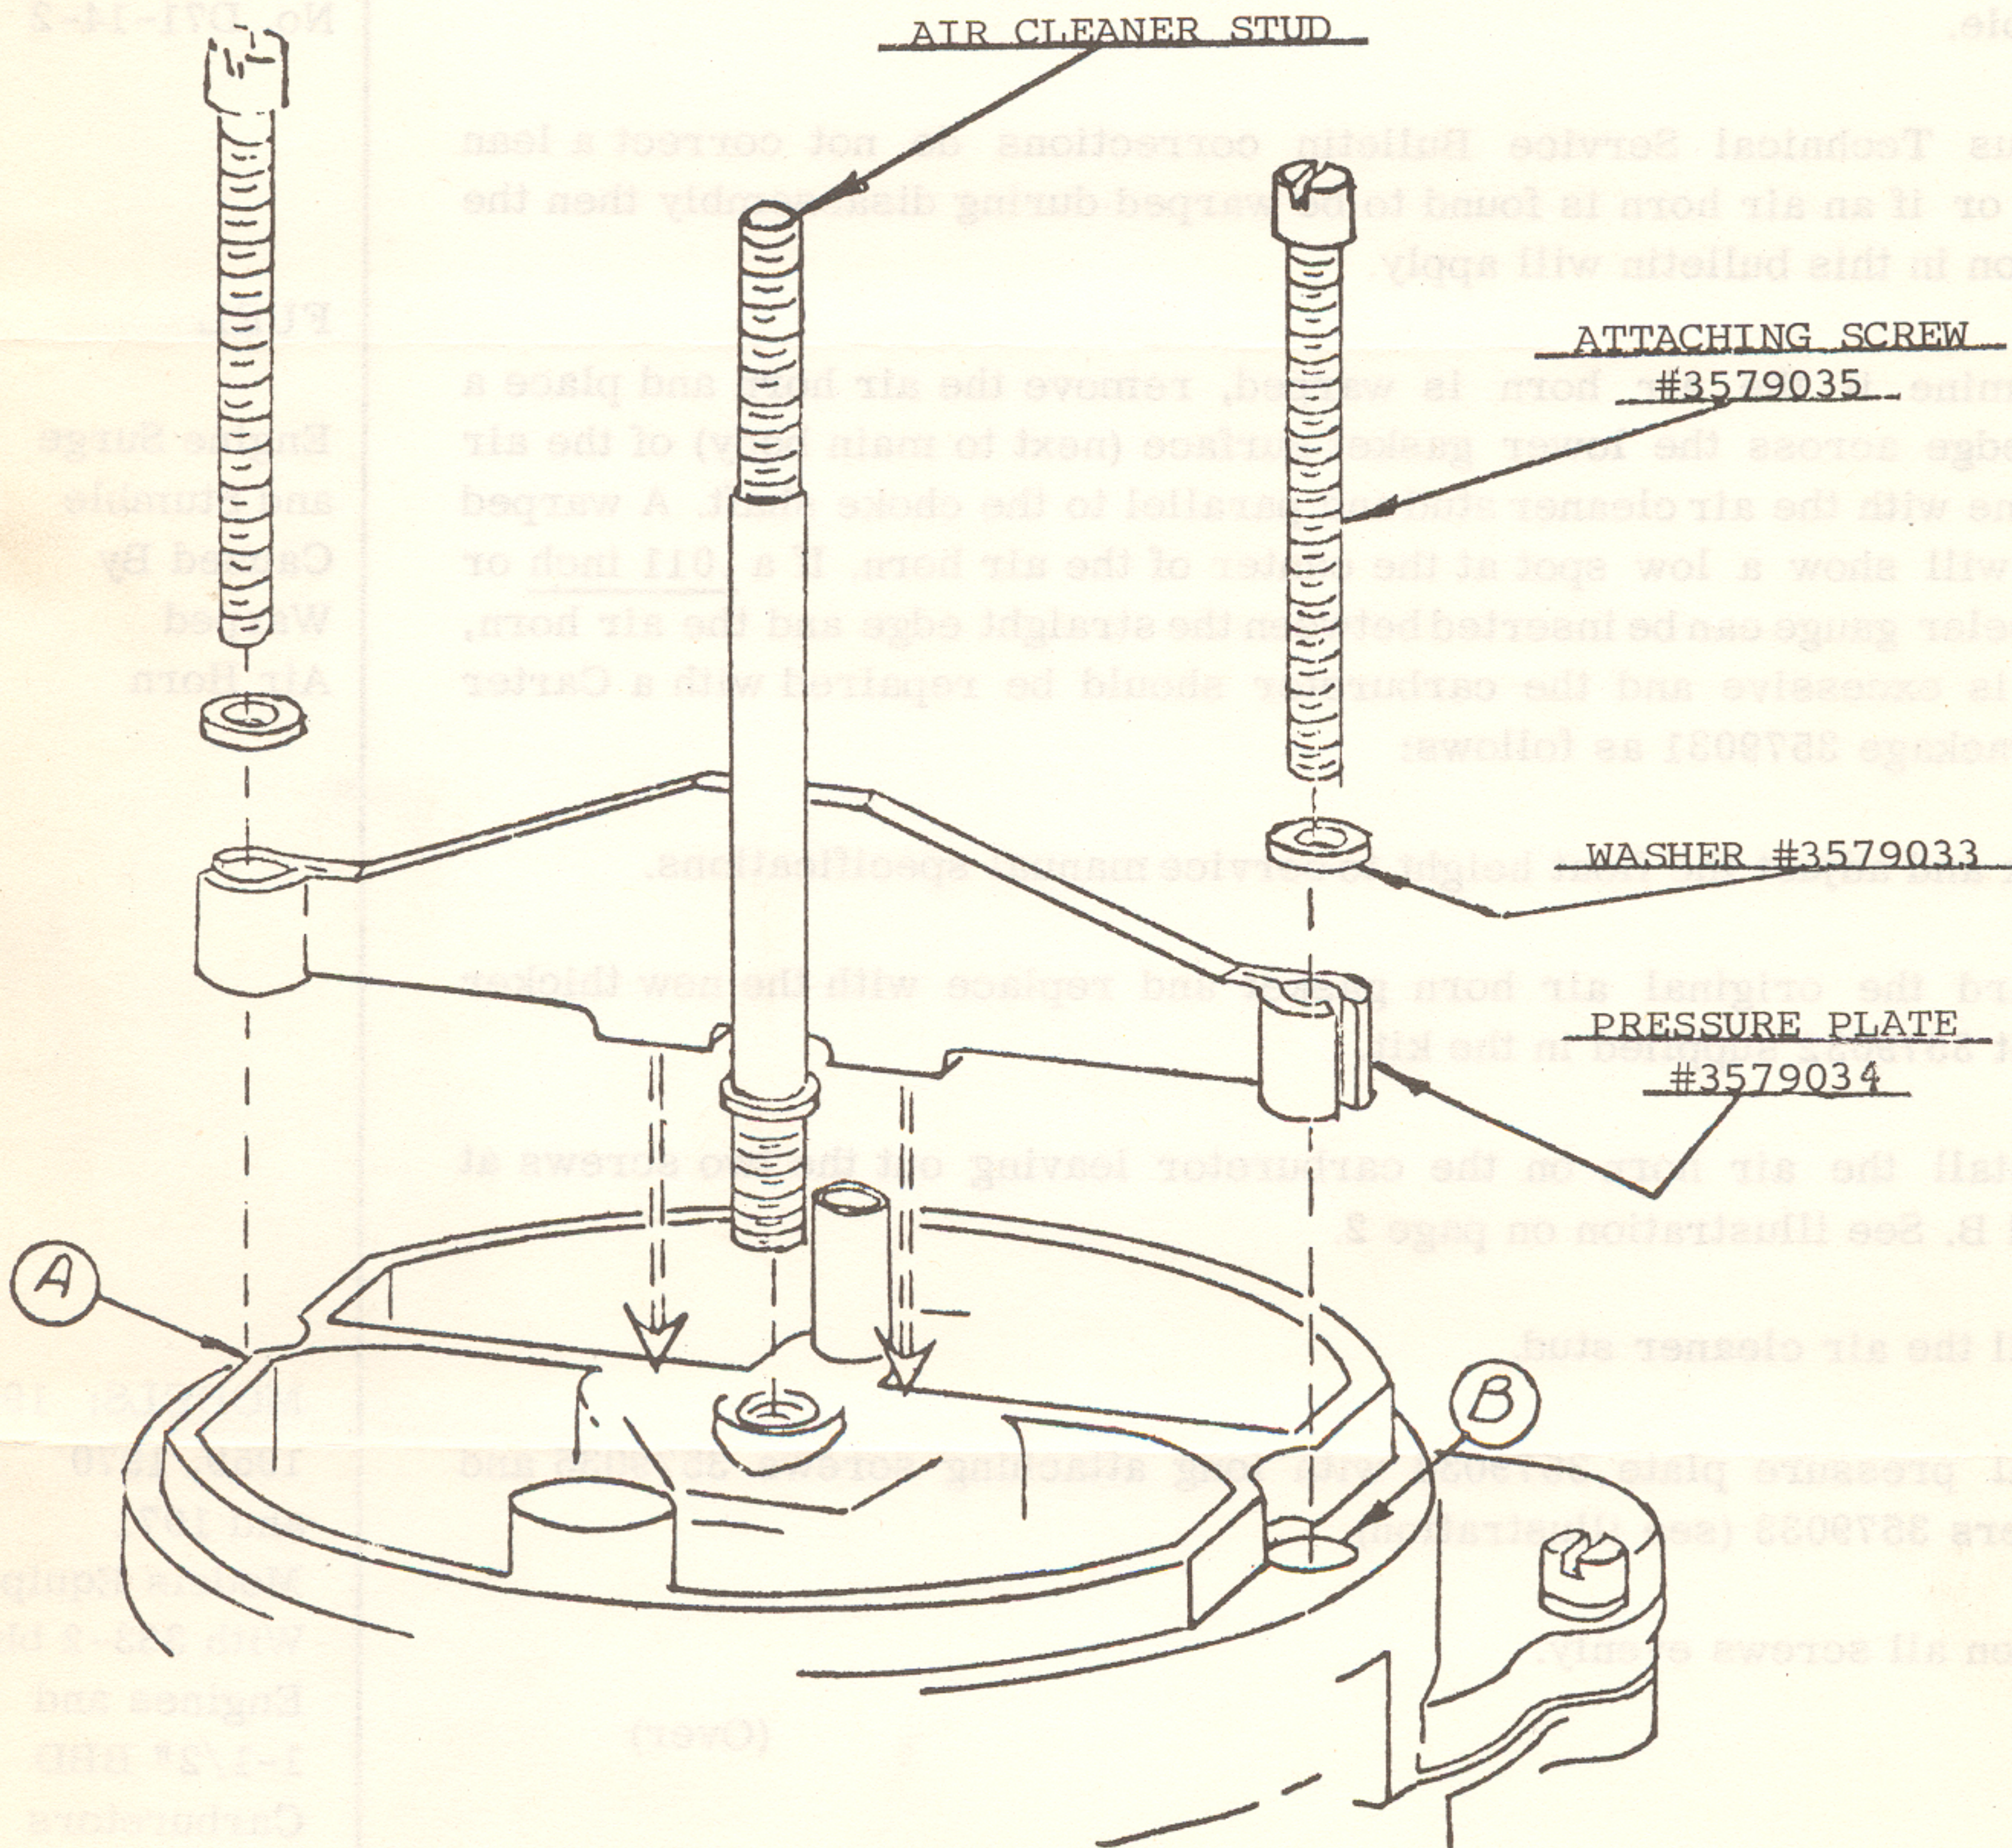
CARTER BBD 1-1/2" AIR HORN CORRECTION

A warped air horn on the 1-1/2" BBD Carter carburetors as used on the 383-2 bbl. engines may cause a lean mixture and result in complaints of surge and stumble.

To determine if the air horn is warped, remove the air horn and place a straight edge across the lower gasket surface (next to main body) of the air horn in line with the air cleaner stud and parallel to the choke shaft. A warped air horn will show a low spot at the center of the air horn. If a .011 inch or thicker feeler gauge can be inserted between the straight edge and the air horn, warpage is excessive and the carburetor should be repaired with a Carter Service Package 3579031 as follows:

1. Check and adjust the float height to service manual specifications.
2. Discard the original air horn gasket and replace with the new thicker gasket 3579032 supplied in the kit.
3. Reinstall the air horn on the carburetor leaving out the two screws at A and B. See illustration on page 2.
4. Install the air cleaner stud.
5. Install pressure plate 3579034 with long attaching screws 3579035 and washers 3579033 (see illustration).
6. Tighten all screws evenly.
