# Technical Service Bulletin

No. D71-8-9

Chrysler  
Electronic  
Ignition  
System

MODELS:  
Dart,  
Challenger  
And Charger  
Equipped With  
340 C.I.D.  
Engine And  
Manual  
Transmission  
P-1306

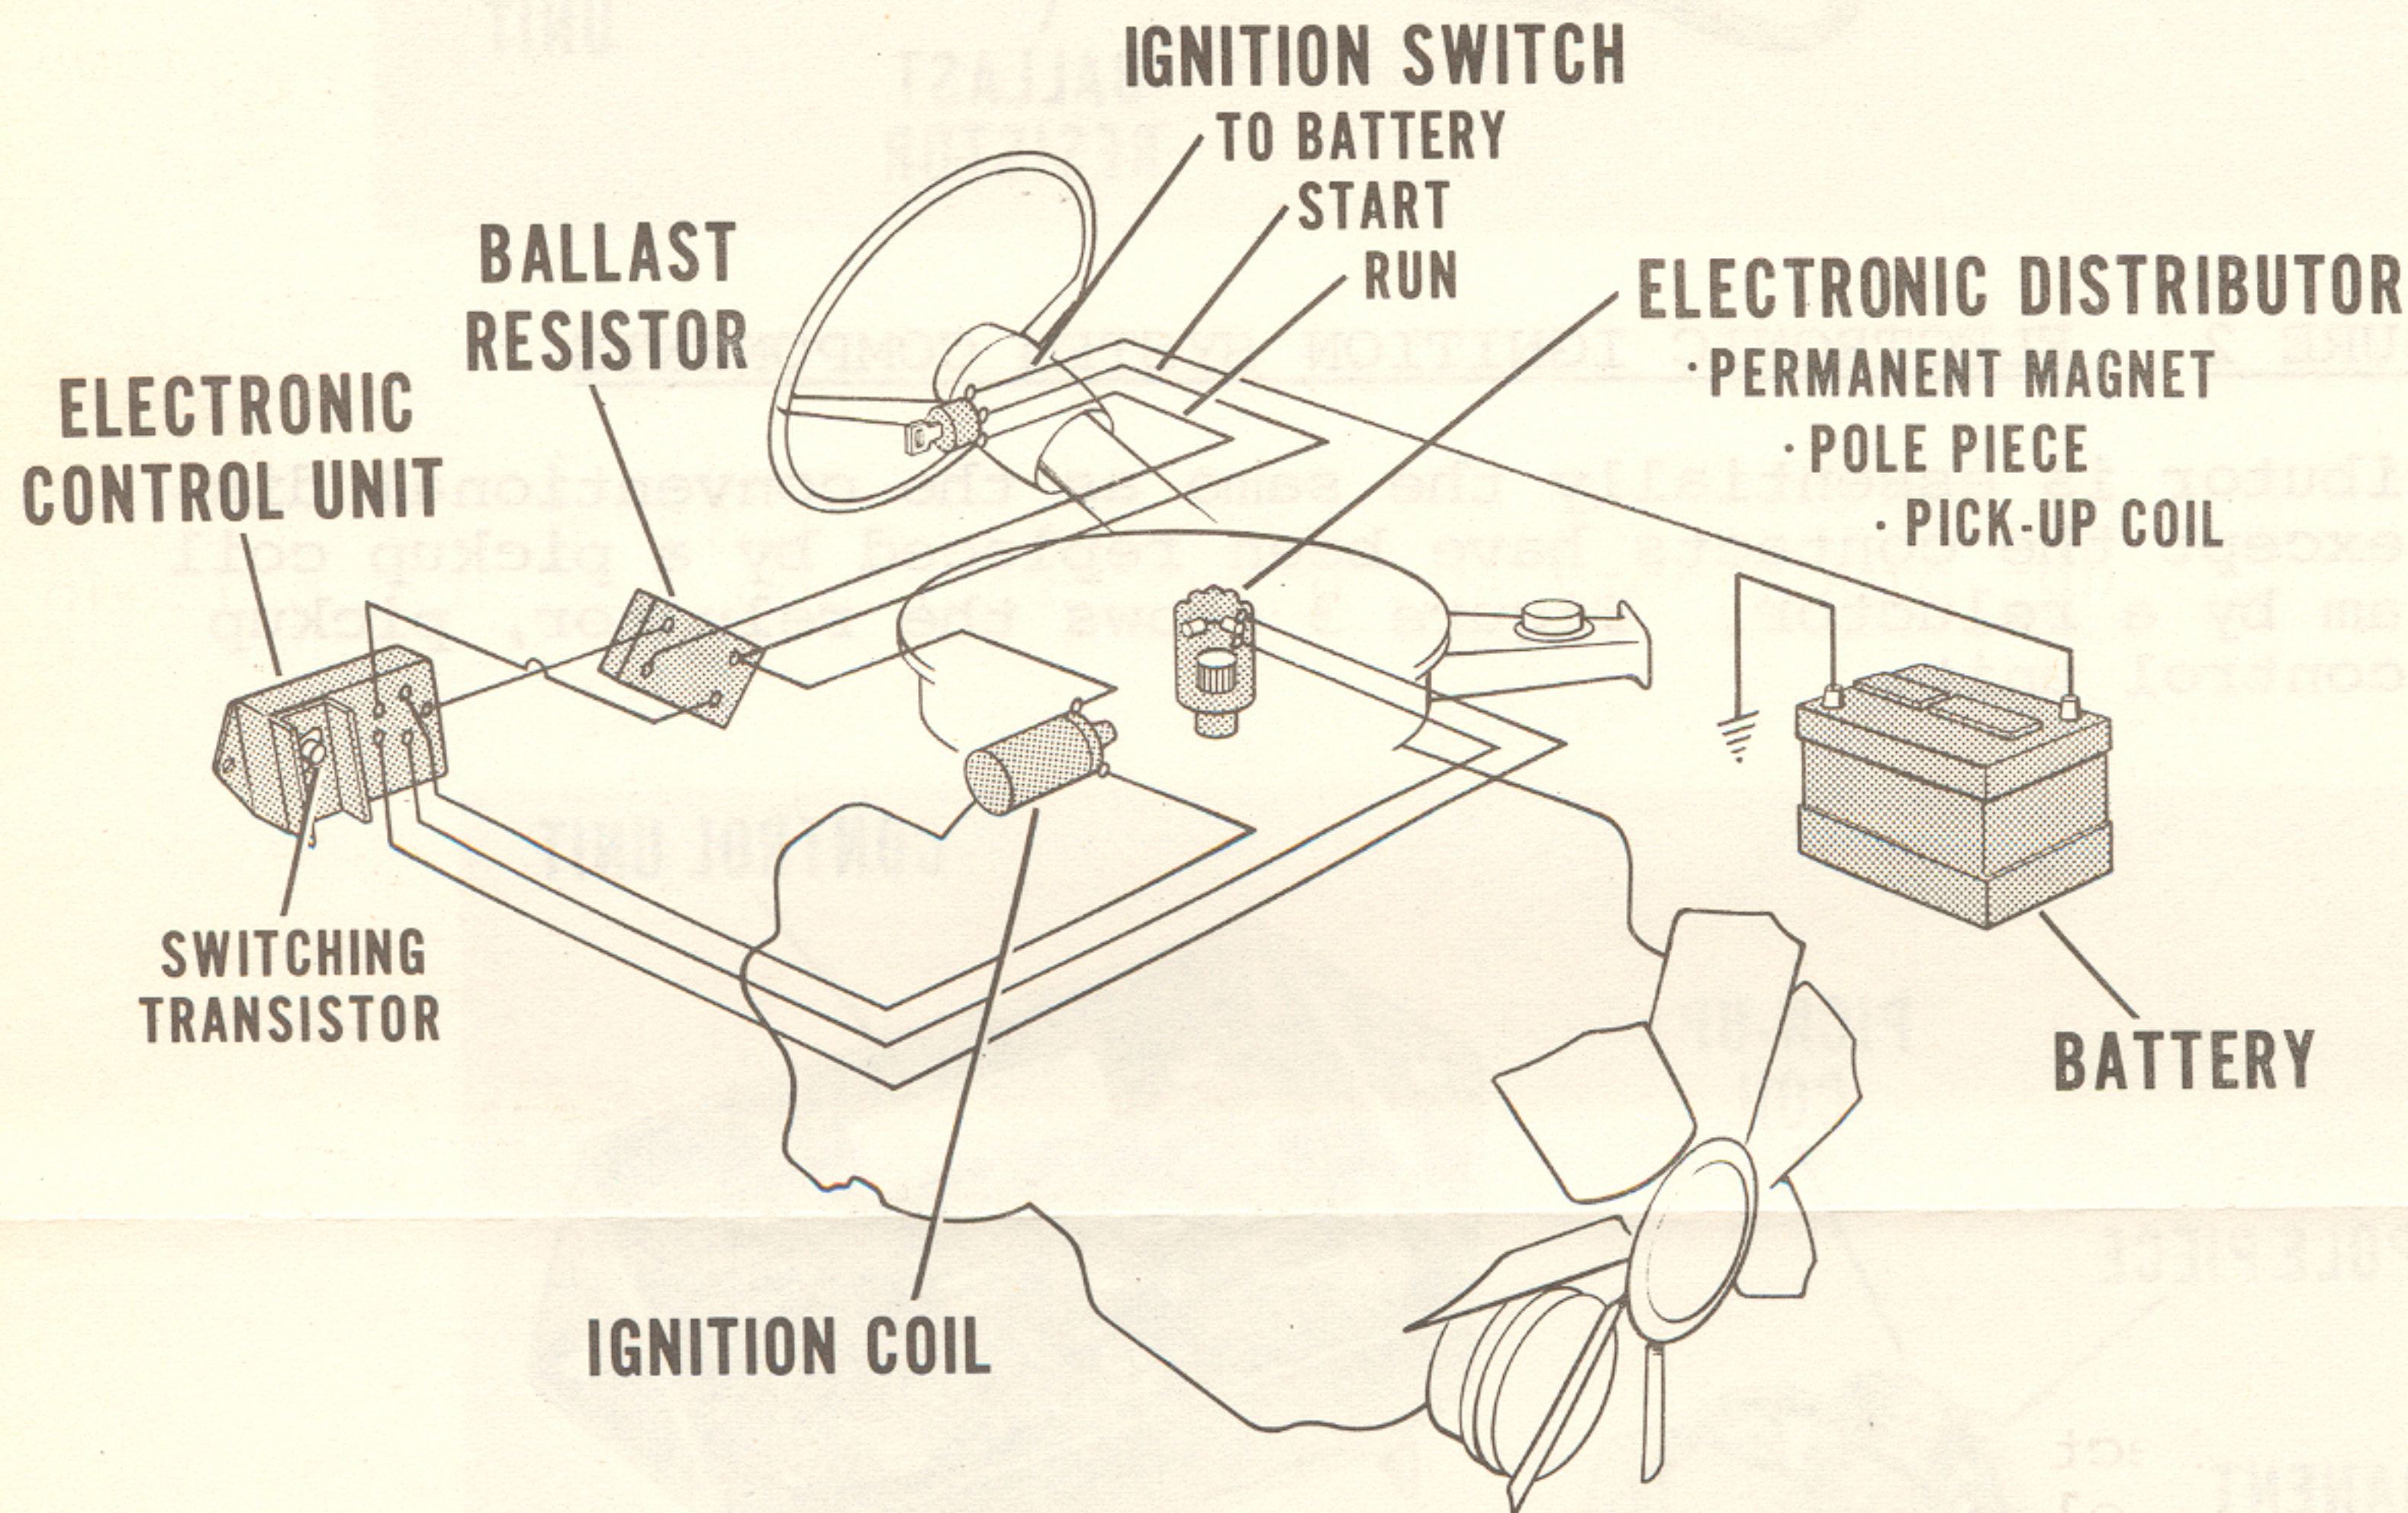
FIGURE 1 CHRYSLER ELECTRONIC IGNITION SYSTEM

Engines with the Electronic Ignition System can be easily identified. The distributor will have a double primary wire. The ballast resistor will be of dual type and a control unit will be mounted on either the dash or fender shield. Figure 1 shows the Chrysler system.

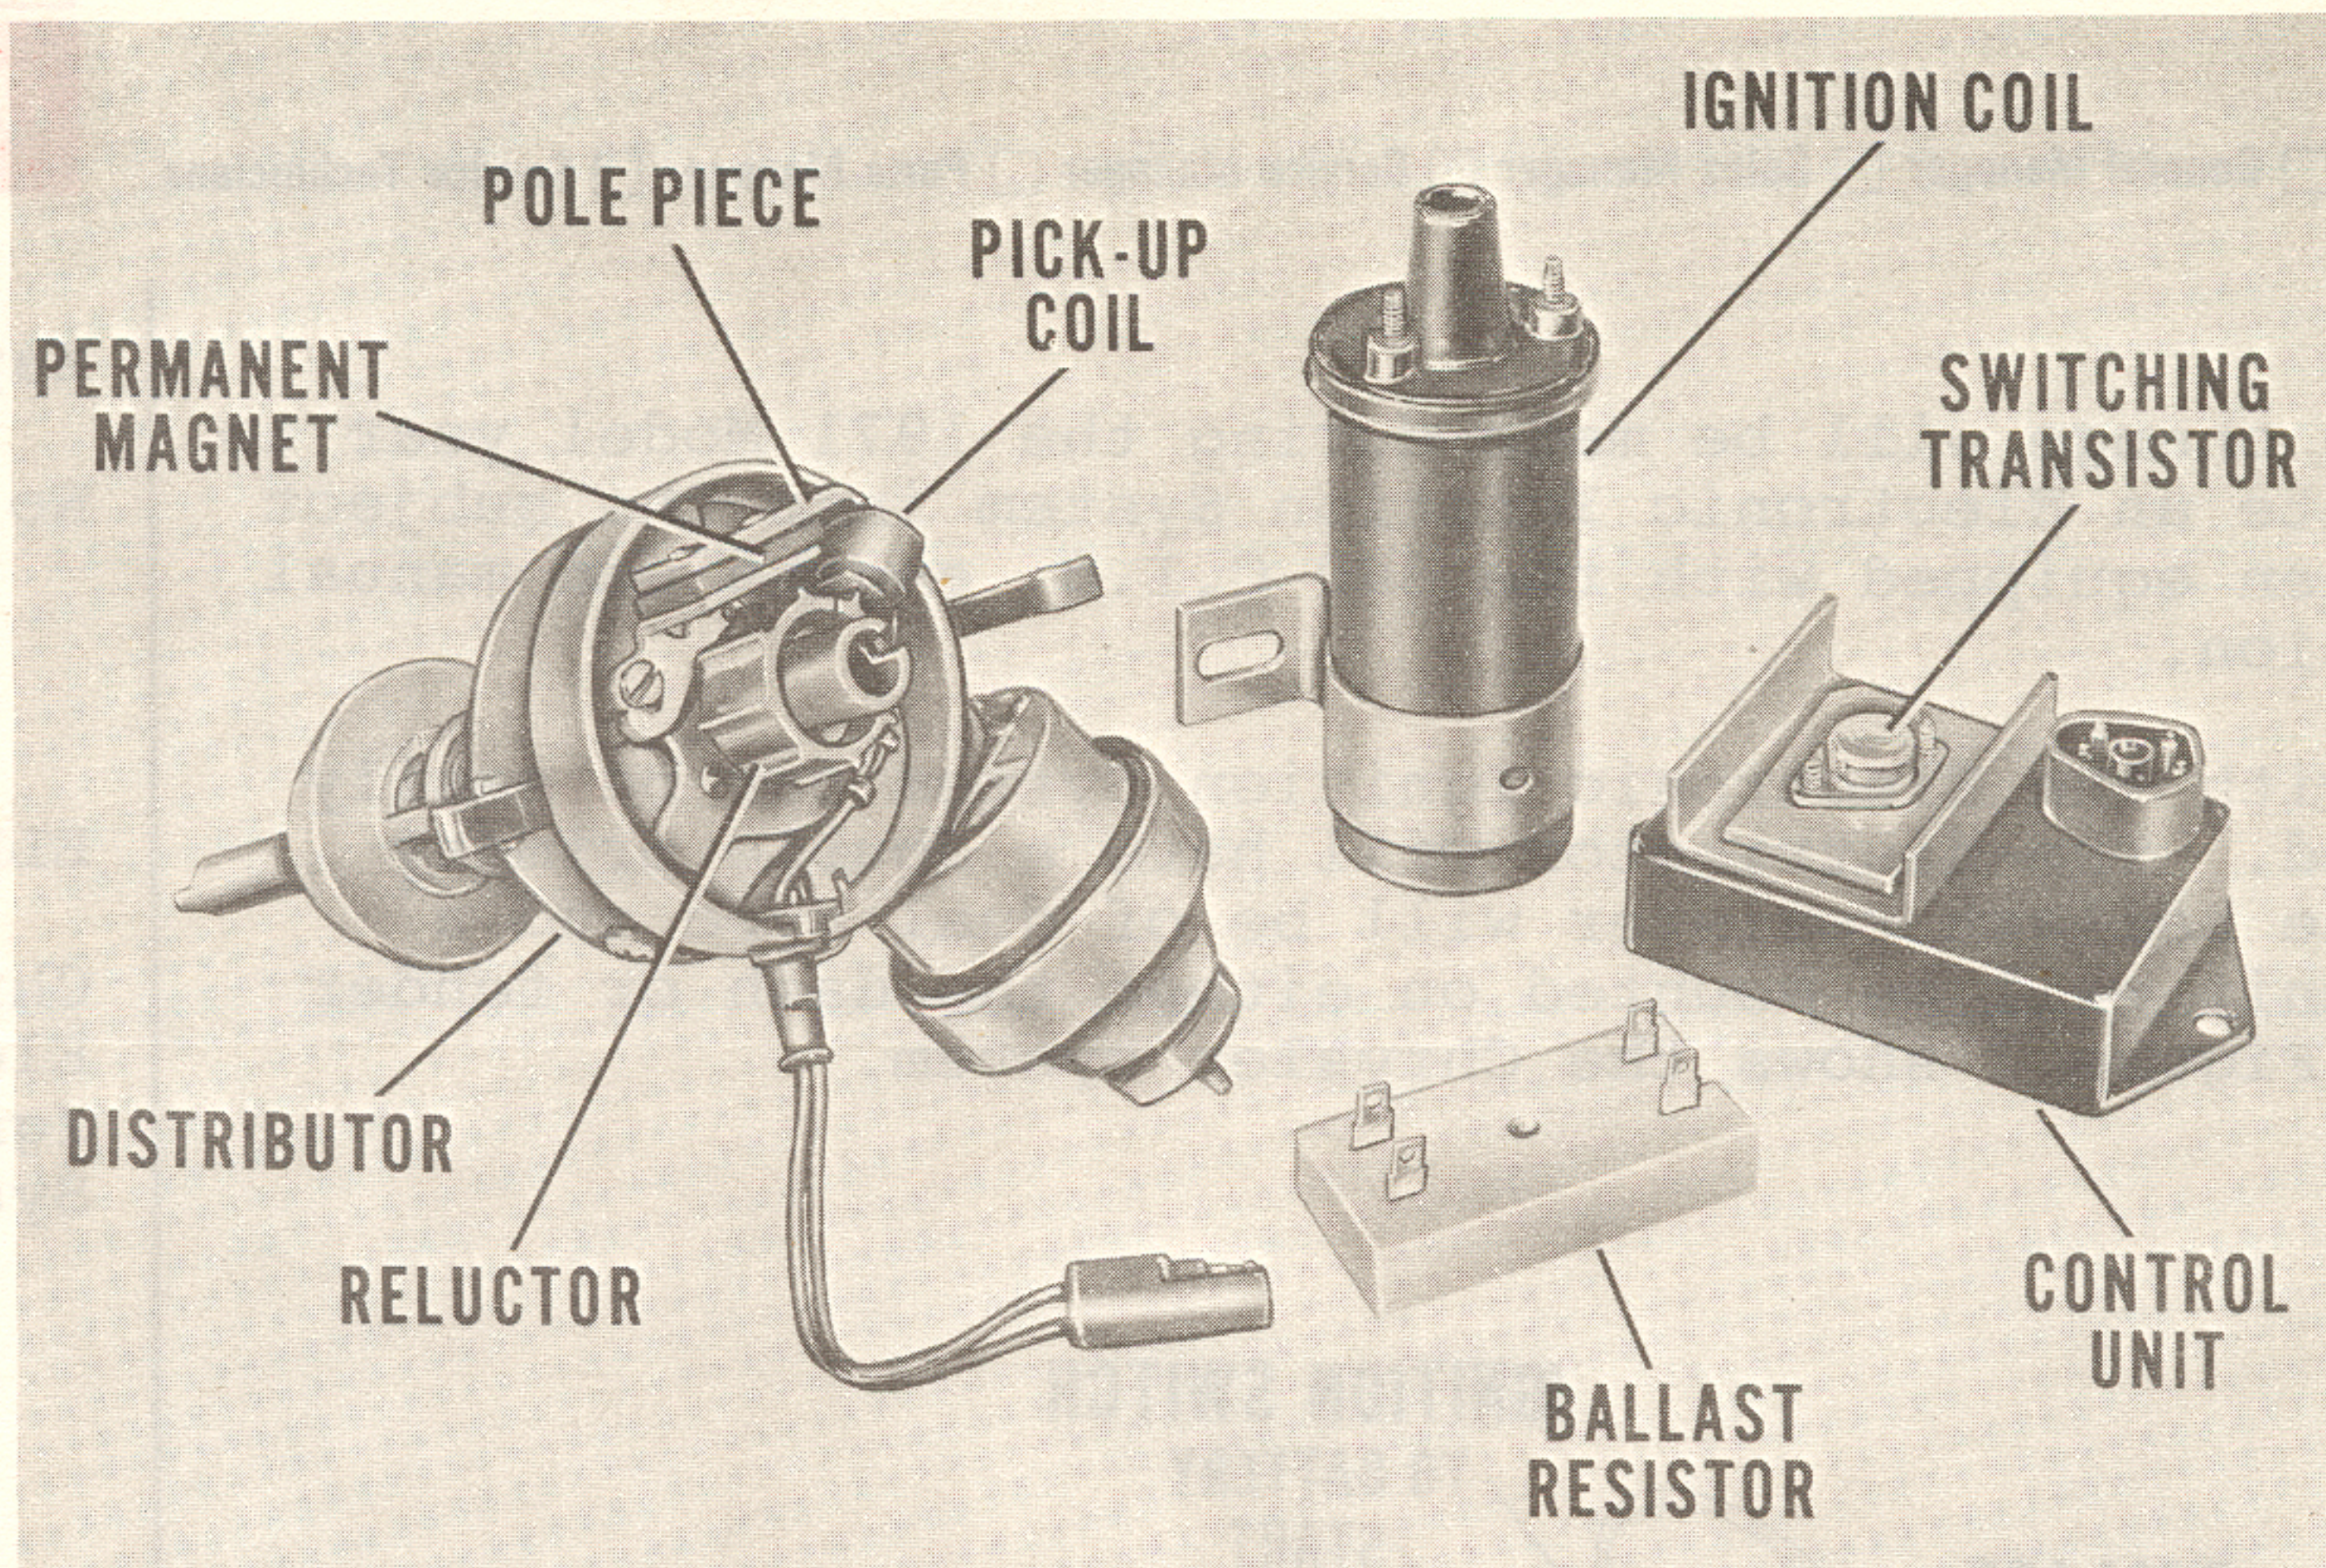
FIGURE 2 ELECTRONIC IGNITION SYSTEM COMPONENTS

The Chrysler Electronic Ignition System is composed of a magnetic distributor, an electronic control unit, a wiring harness, a production coil and a dual ballast resistor. See Figure 2.

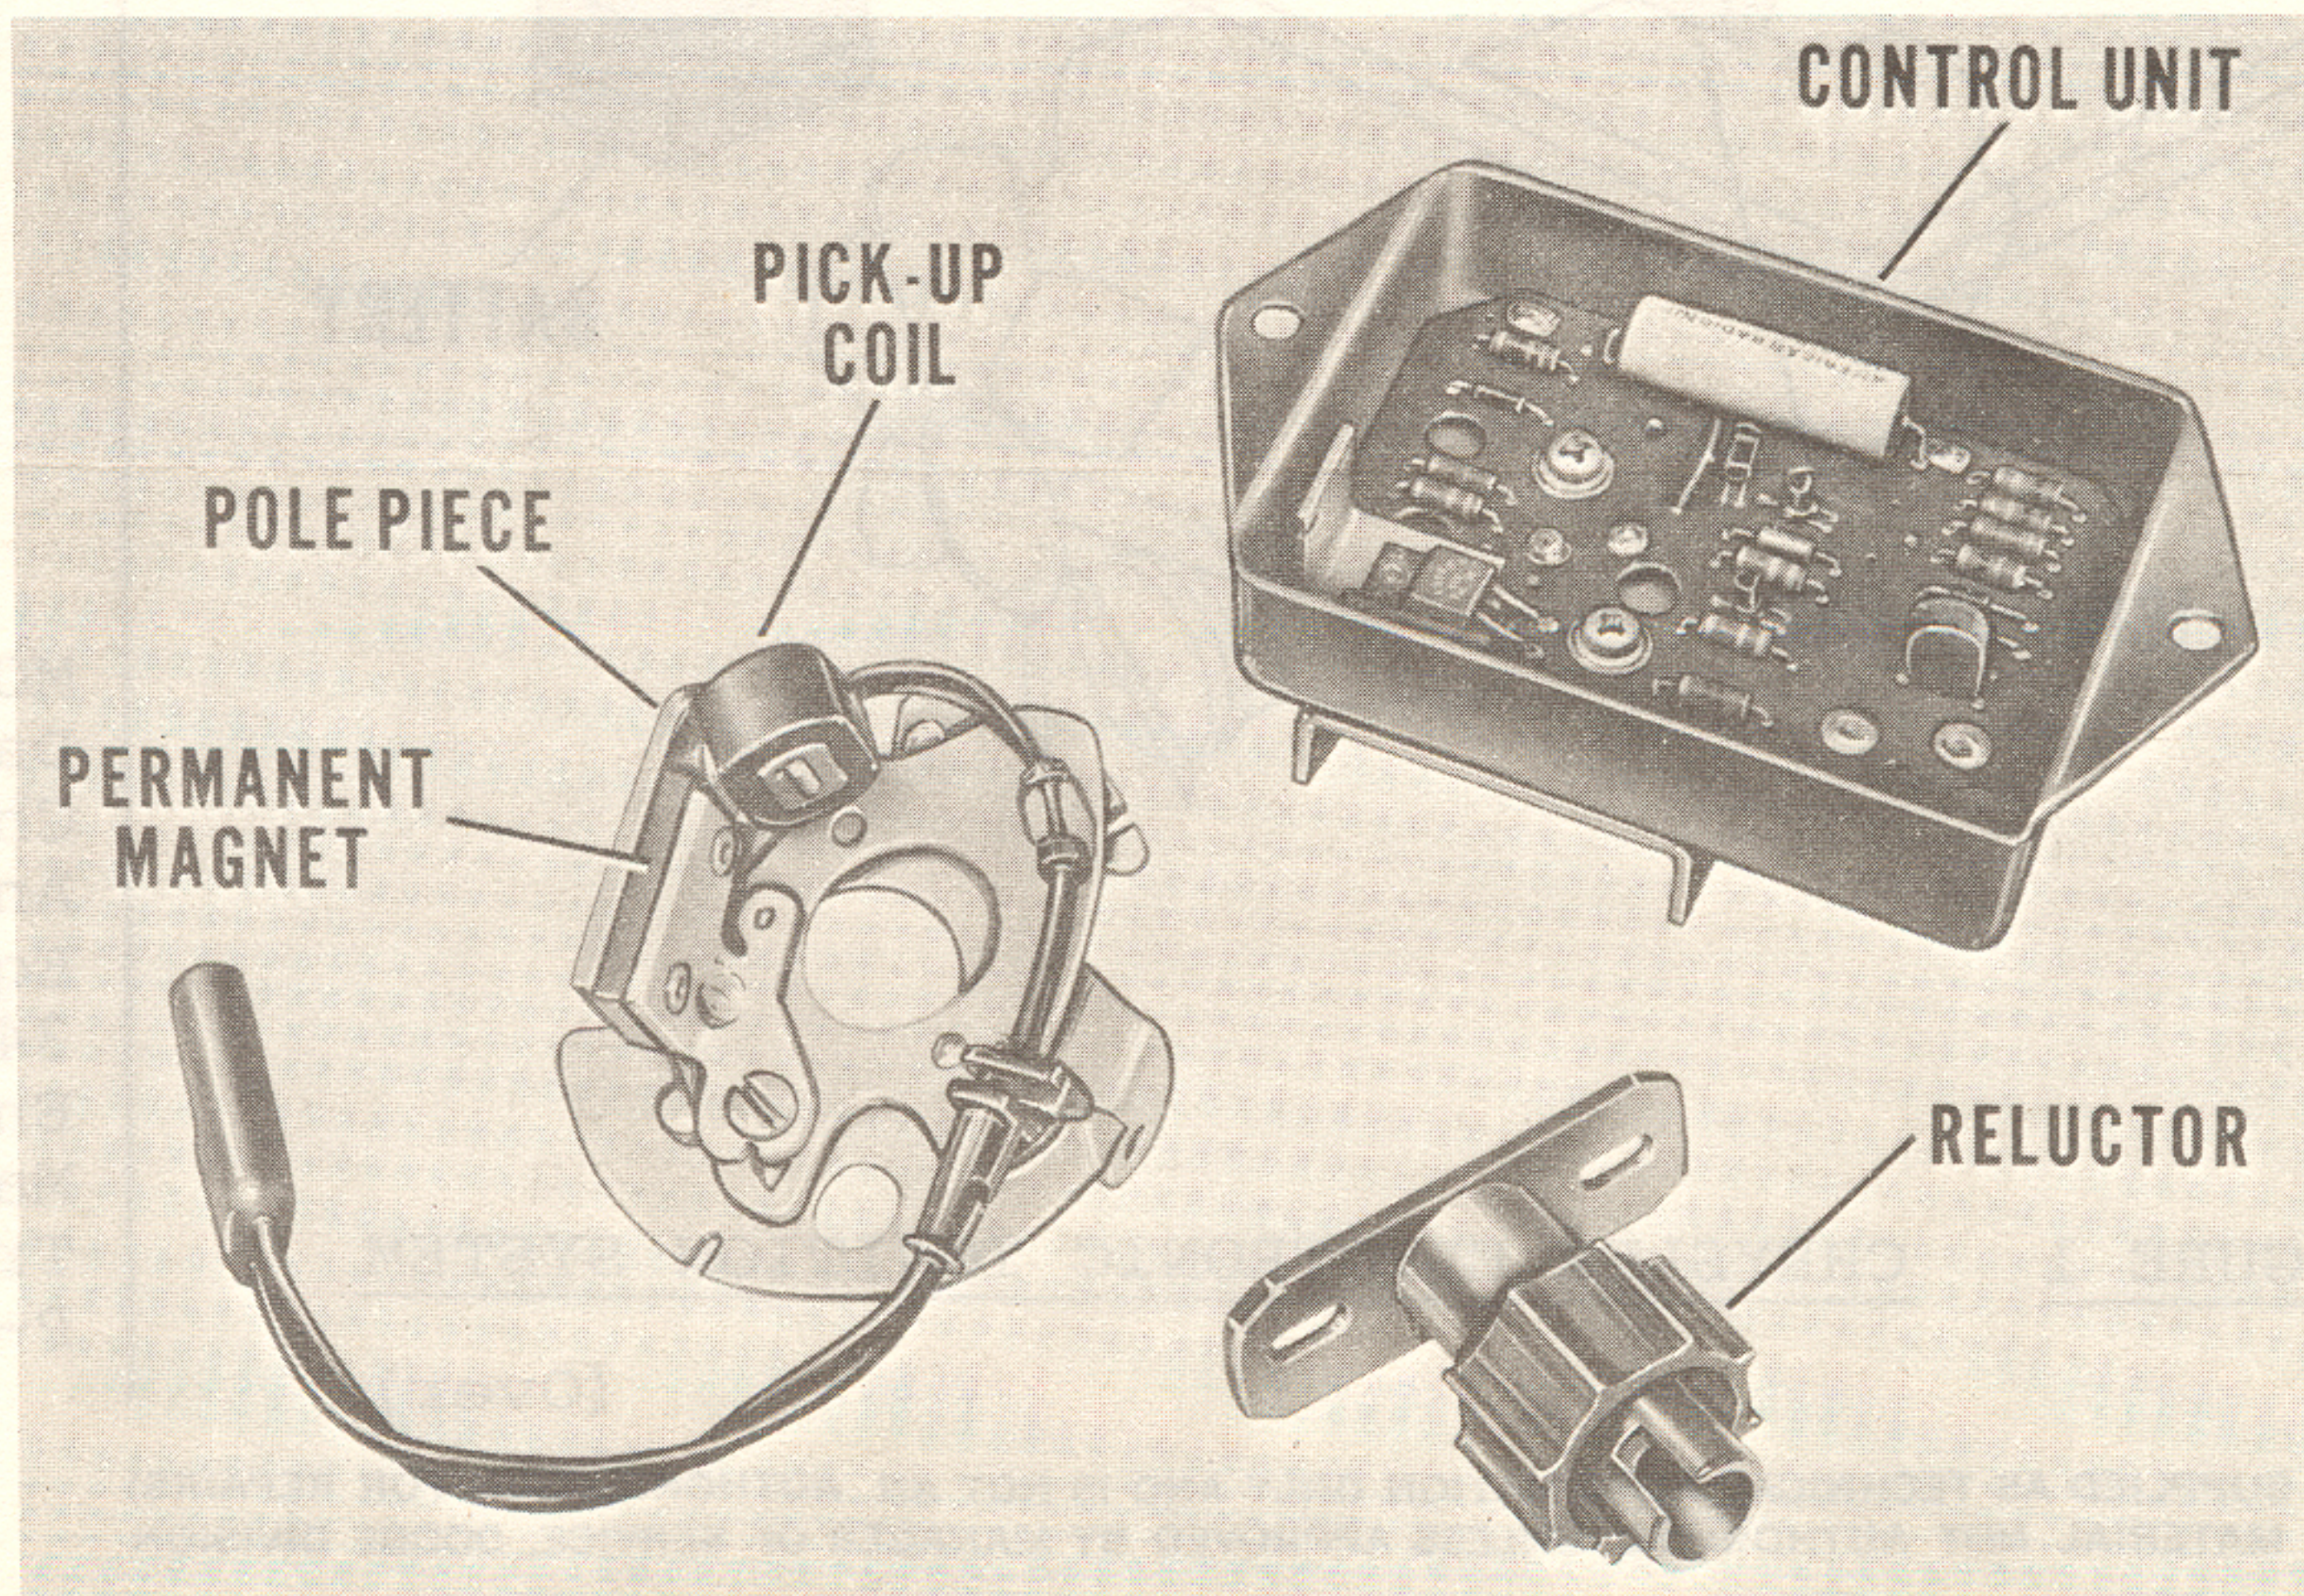
FIGURE 3 MAGNETIC PICKUP COMPONENT AND CONTROL UNIT

The distributor is essentially the same as the conventional distributor except the contacts have been replaced by a pickup coil and the cam by a reluctor. Figure 3 shows the reluctor, pickup coil and control unit.
