Technical Service Bulletin

No. D71-1-6

Radio Noise

MODELS: 1971
Coronet and
Charger So
Equipped
P-1476-C

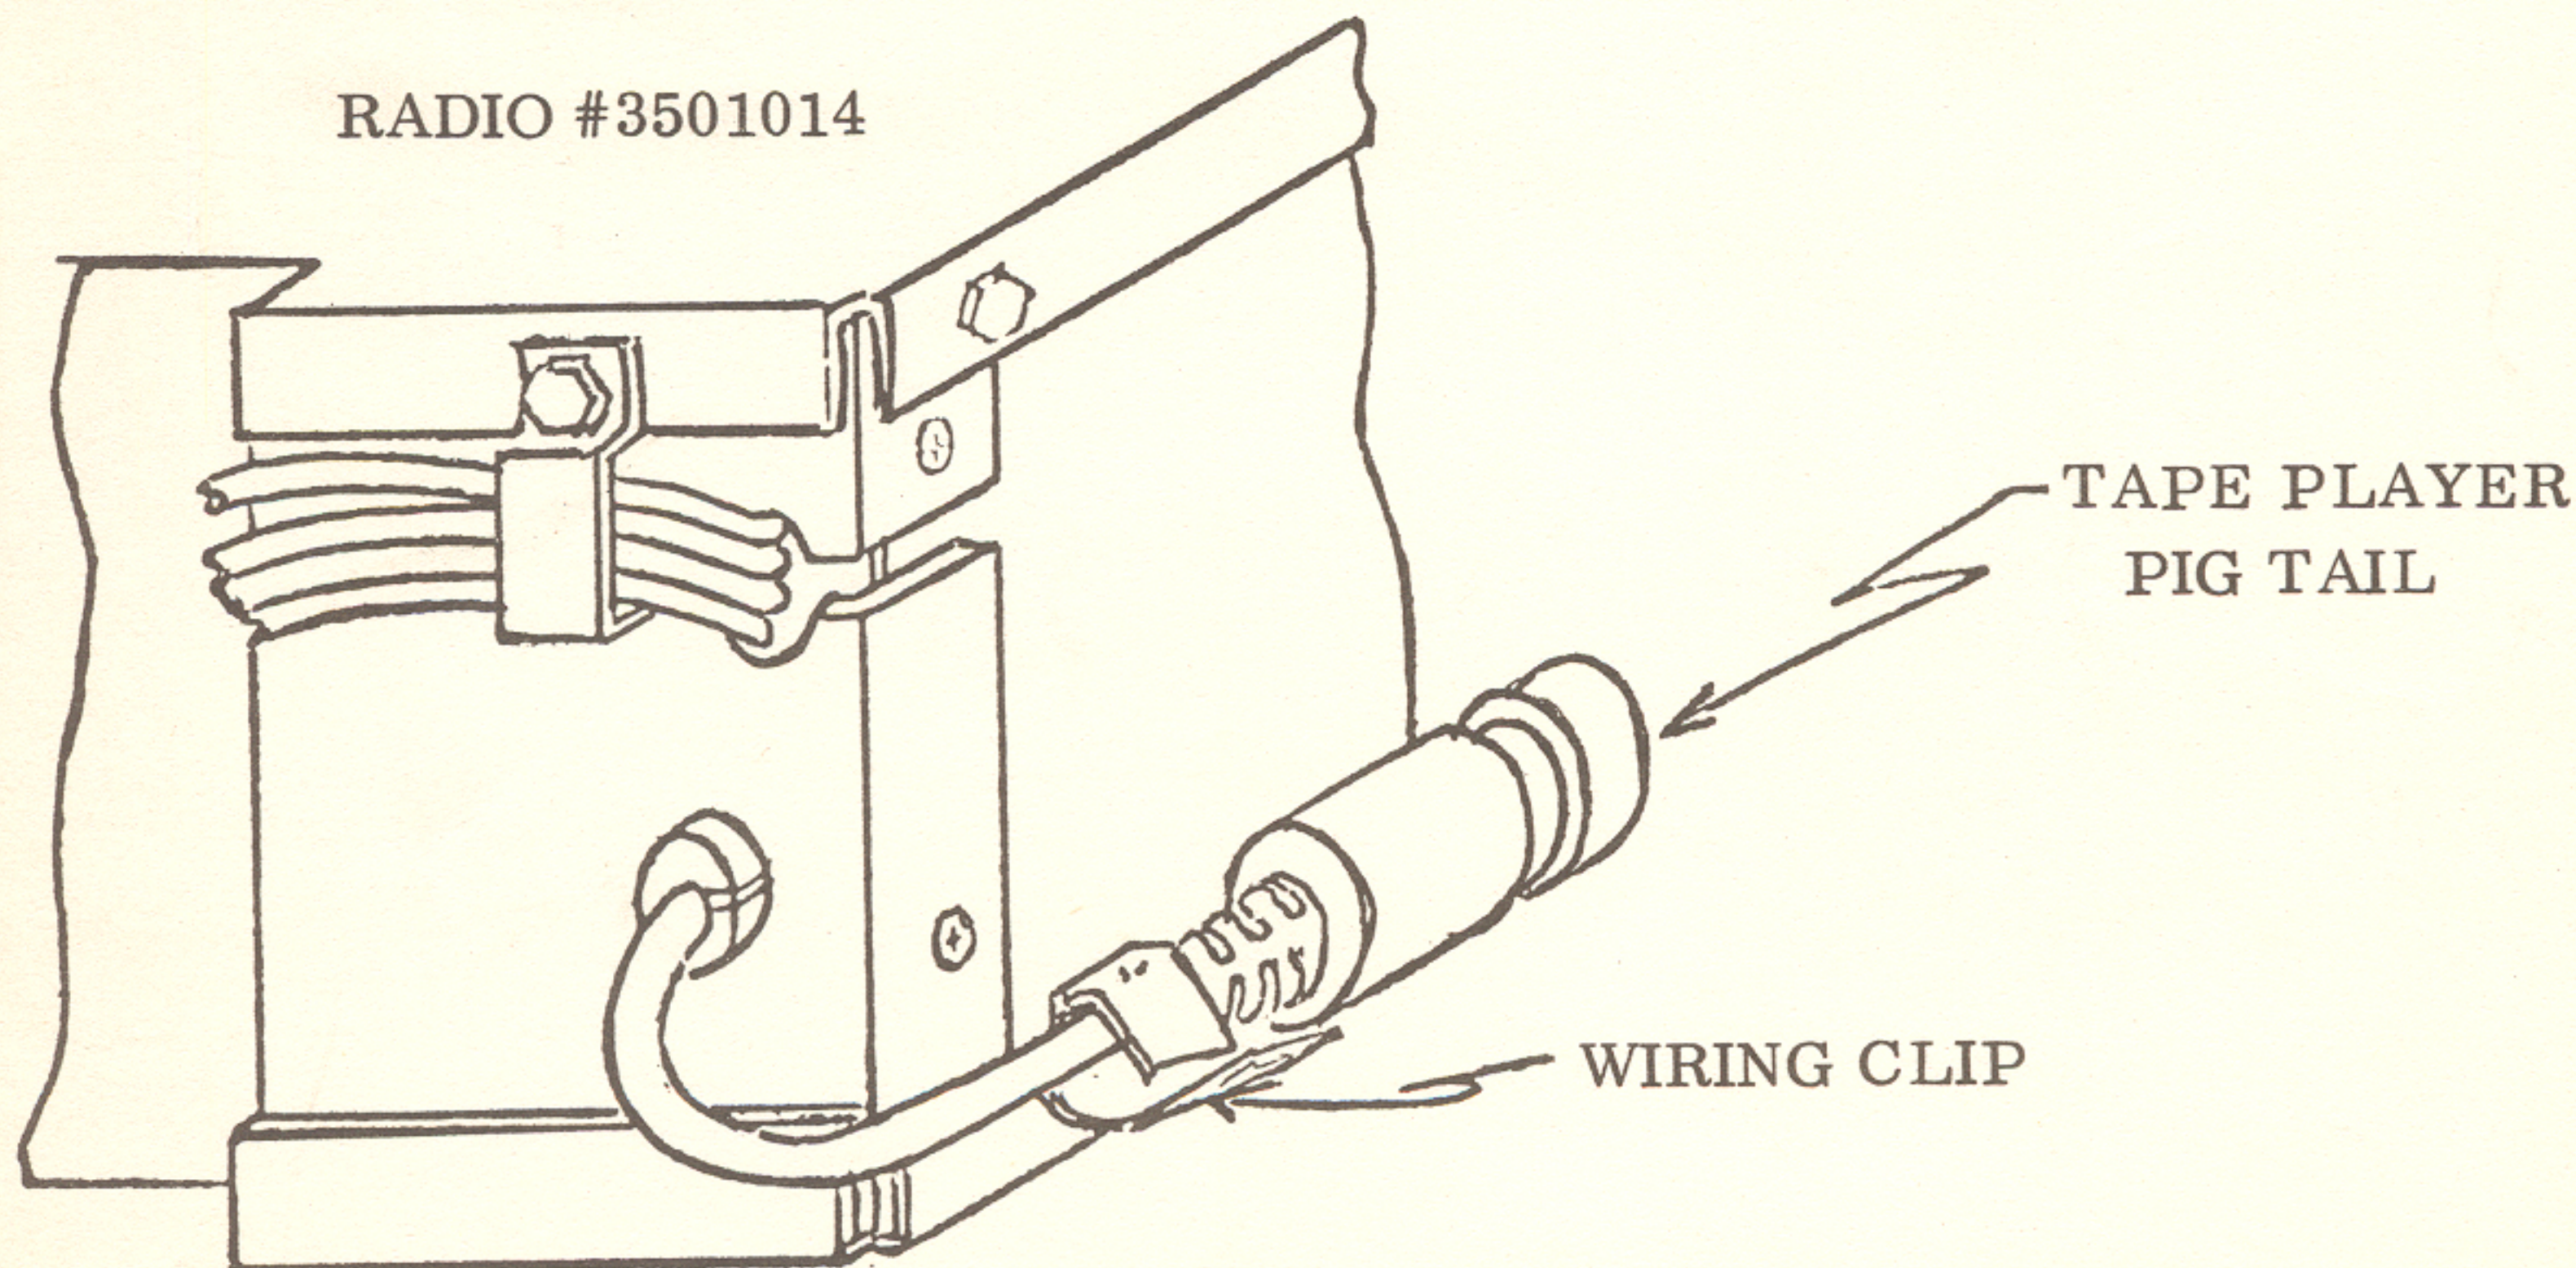
Complaints of ignition noise with AM/FM/MX radio, Mark I (Part No. 3501014) in 1971 cars, may be caused by the location of the tape player pig tail to the car wiring (see illustration). The pig tail performs like an antenna, and transmits the ignition noise from the car wiring to the radio system.

Cars equipped with radio identification Mark II and/or tape player should not experience this condition, since the interconnecting cable is satisfactorily dressed along the rear of the radio chassis and secured from the car wiring.

In order to minimize this noise, relocate the pig tail cable by adding an additional wiring clip, as shown in the illustration.

Mark I radios have a wiring clip now near the antenna ferrule. Remove and relocate this clip or fabricate one as shown in illustration.
