Technical Service Bulletin

No. 71-21-11

TRANSMISSION

Erratic,
Delayed, or
No shifts into
Direct or
Reverse

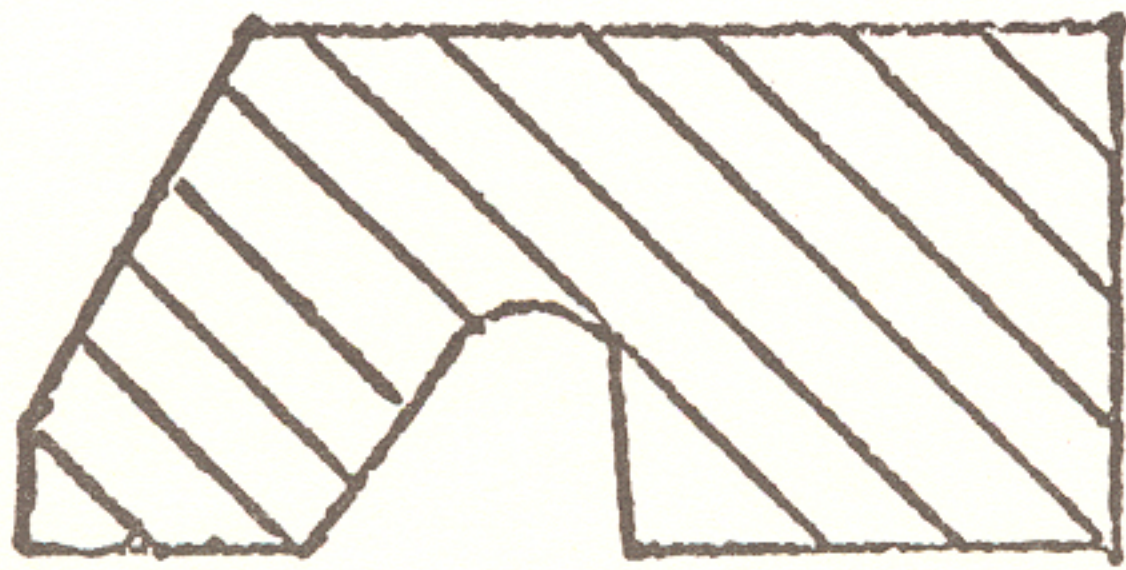
FIGURE #1

CROSS SECTION OF
 A NEW 1971-A727
 TRANSMISSION SHORT
 LIP FRONT CLUTCH
 SEAL

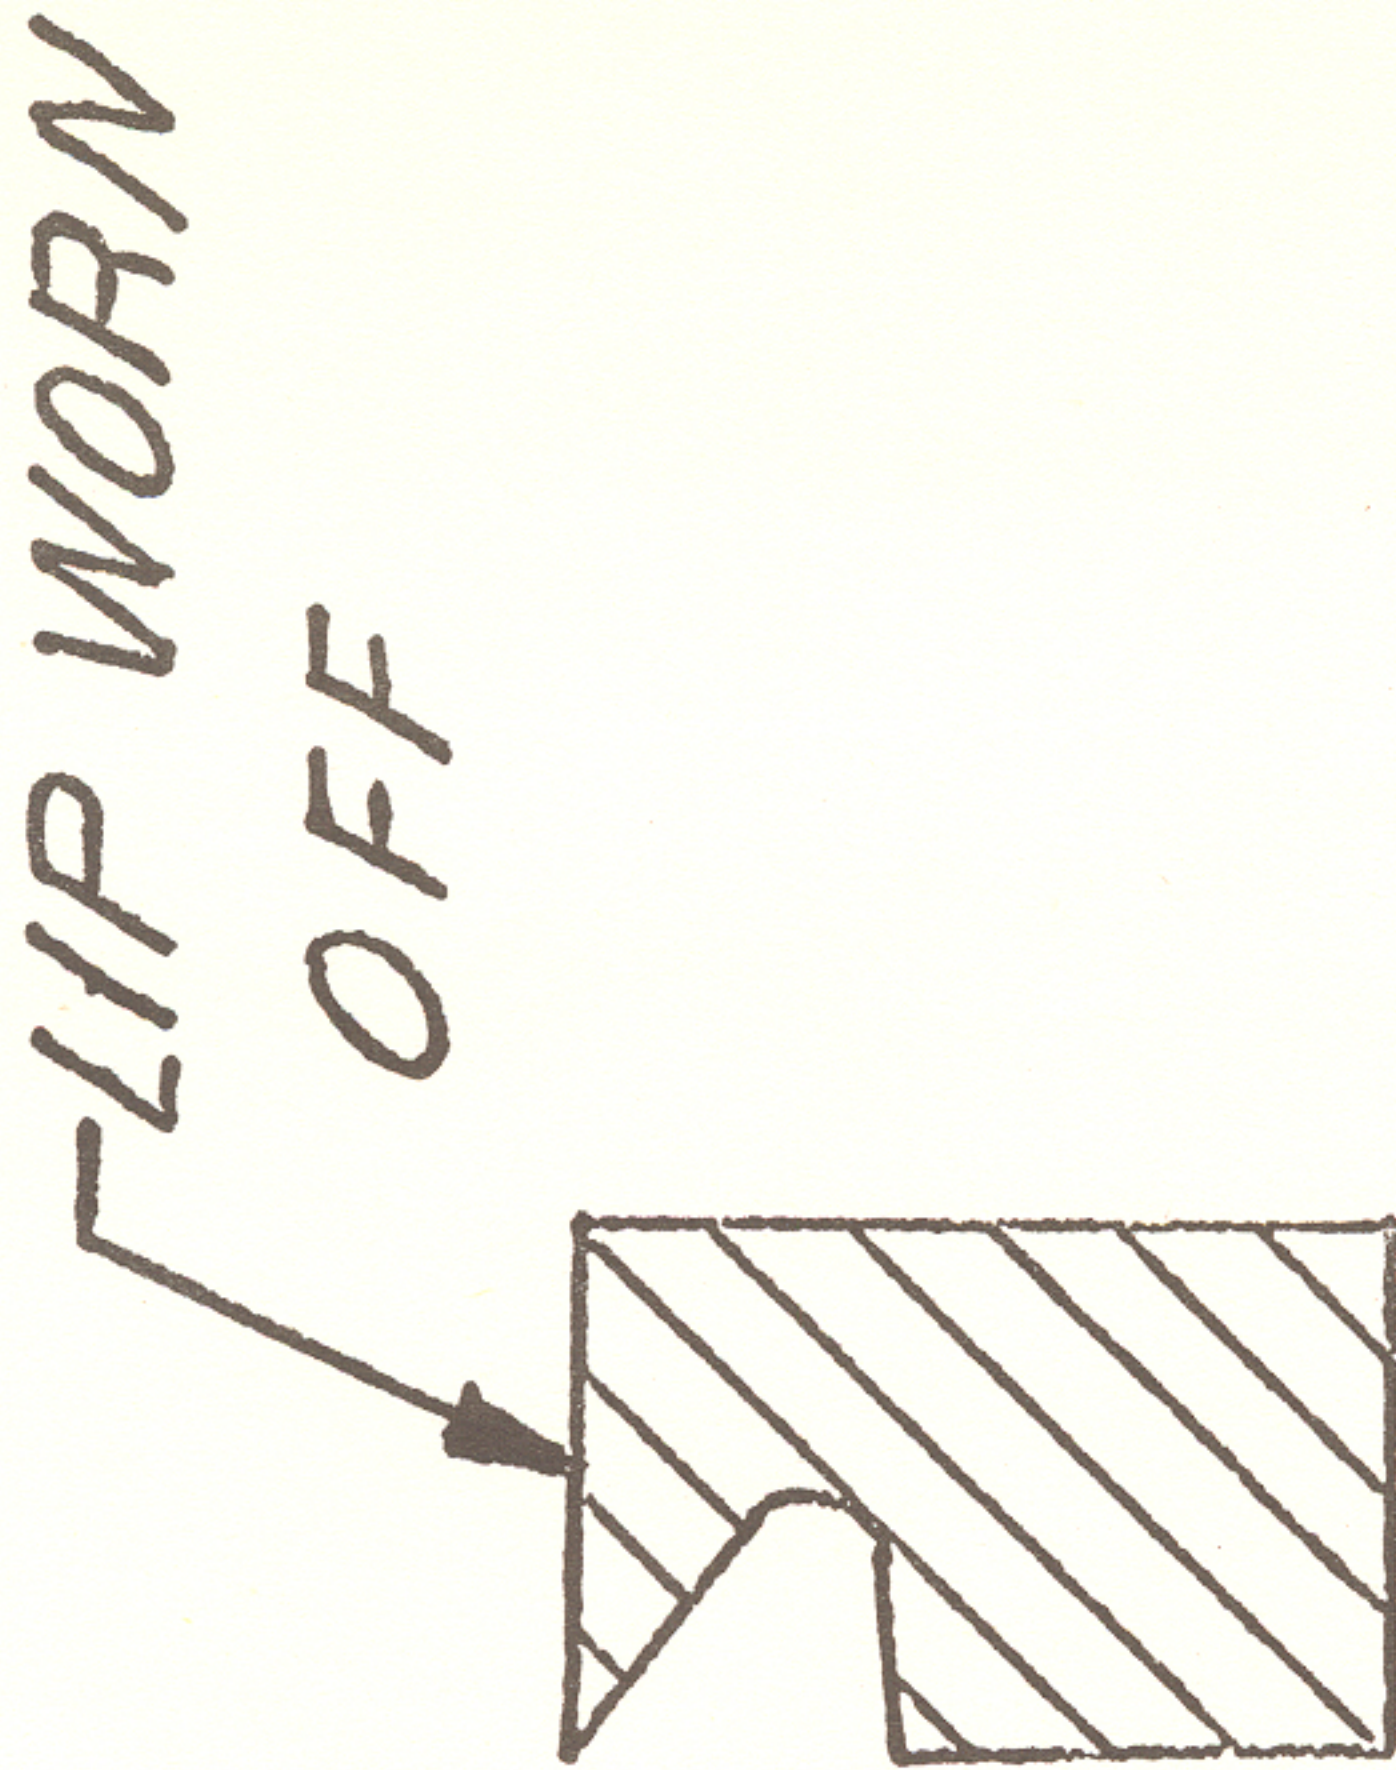
FIGURE #2

If you encounter erratic, delayed, or no shifts into Direct Drive (2-3 shift) or Reverse, it may be caused by a severely worn front clutch outer "short lip" seal, (Part No. 3410225). The following procedure will aid in diagnosing and correcting this condition.

CROSS SECTION OF
 A WORN OUT 1971-A727
 TRANSMISSION SHORT
 LIP FRONT CLUTCH
 SEAL

4. Install new seals if inspection reveals the removed seals are defective.
5. Replace the front clutch retainer if the outer seal shows excessive wear. Excessive wear indicates the seal was rubbing against a rough surface which may cause a repeat failure.
