Technical Service Bulletin

TRANSMISSION

Valve Body
High Pressure
Relief Ball
Identification

MODELS: All
1968 Through
1971 Models
Equipped With
A-904 or A-727
Transmission

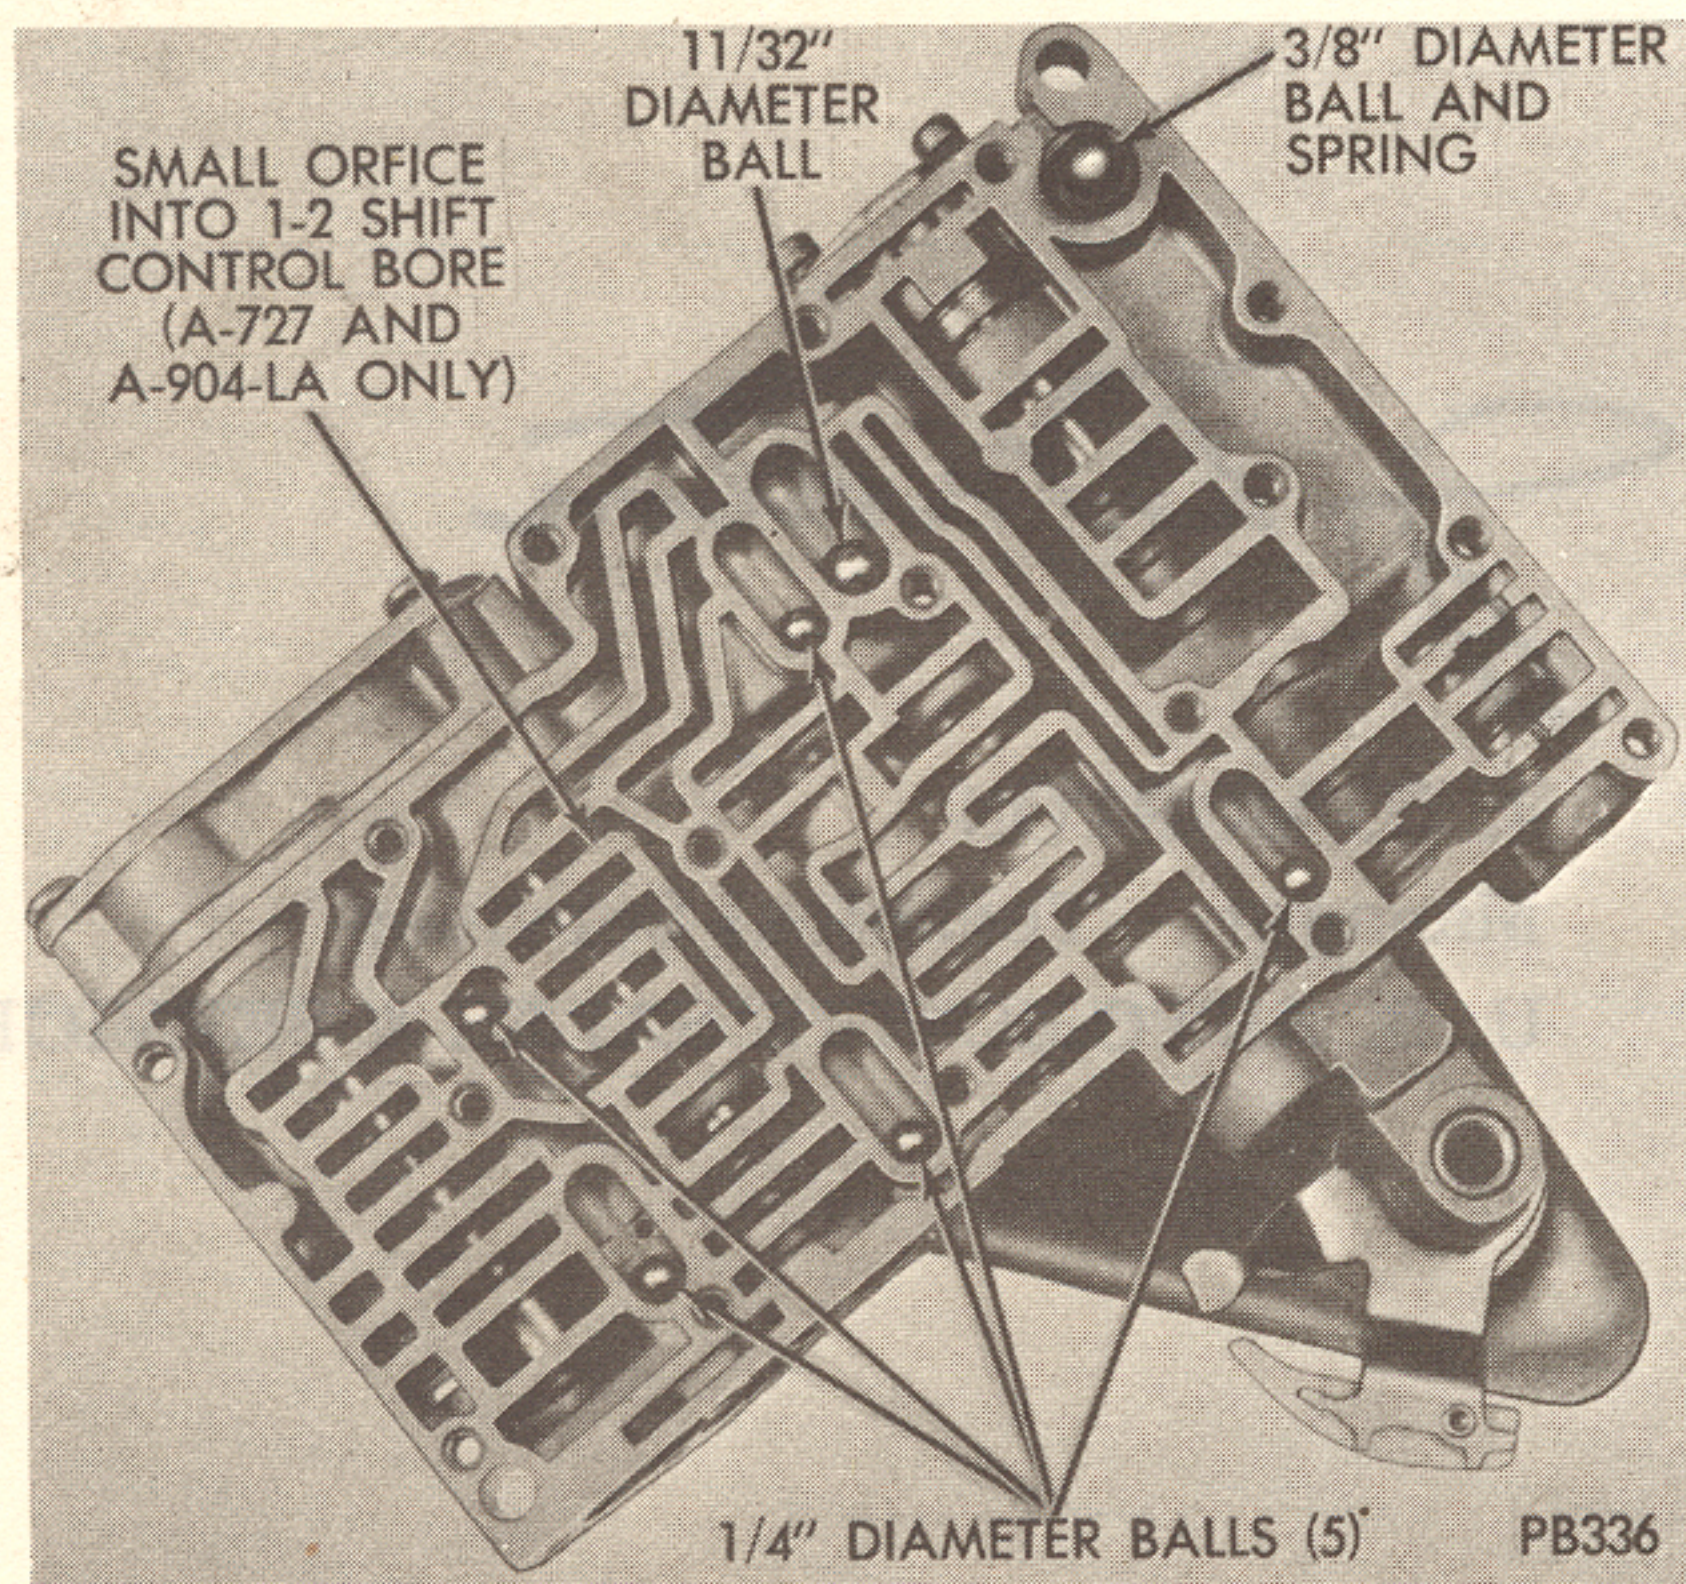
STEEL BALL LOCATIONS

Early in the 1971 model year the high pressure relief ball (3/8 diameter) in the transmission valve body was changed from a "dull finish" to a "bright finish" to improve its seating ability. At the same time the number 3 check ball (11/32 diameter) was changed from a bright finish to a dull copper finish to prevent it from being interchanged with the high pressure relief ball.

Interchanging the balls will cause excessive leakage in the front clutch circuit at the Number 3 check ball, and may cause high pressure relief ball not to seat properly.

The balls must be assembled as shown in the picture and chart. (No high pressure relief ball was used up to 1968.)
