# **Technical Service Bulletin**

*	No. 21-07-73C
The information included in this Bulletin will update you on all major changes affecting the <b>1966</b> through <b>1973</b> TorqueFlite Transmission. It is also a quick reference guide for any interchangeability that was taken during the above model years.	MAJOR CHANGES AFFECTING FIELD SERVICE 1966 THROUGH 1973
We suggest you refer to this Booklet whenever you encounter a trans- mission failure.

Cricket/Imperial/Chrysler/Fury/Satellite/Valiant

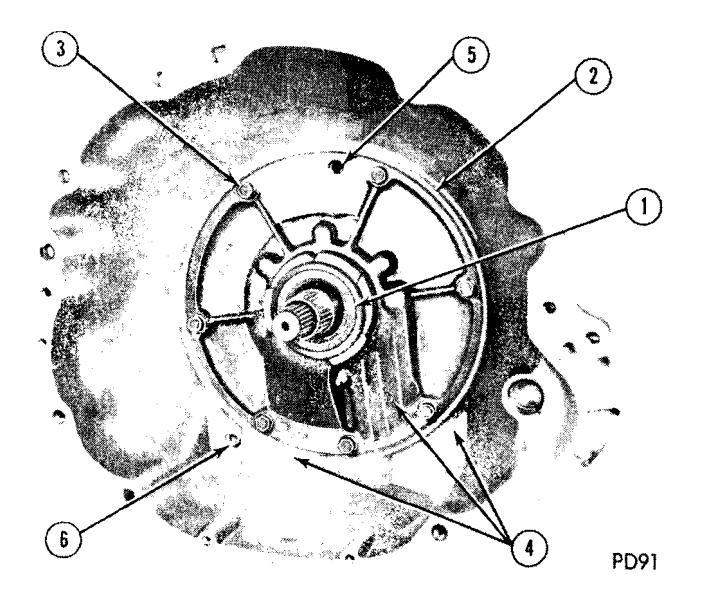
Fig. 5 – Transmission Converter Area

(4) Fluid leakage due to case or front pump housing porosity.

- (5) Oil leakage out the vent.
- (6) Kickdown lever shaft access plug.

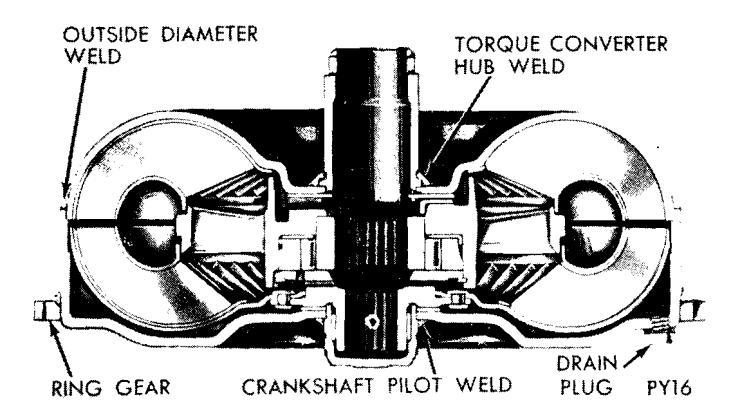
Fig. 6 – Torque Converter Cross Section

### Converter Leakage (Fig. 6)
