Technical Service Bulletin

Car #: D71-24-2

AIR
CONDITIONING

Compressor
Leaks

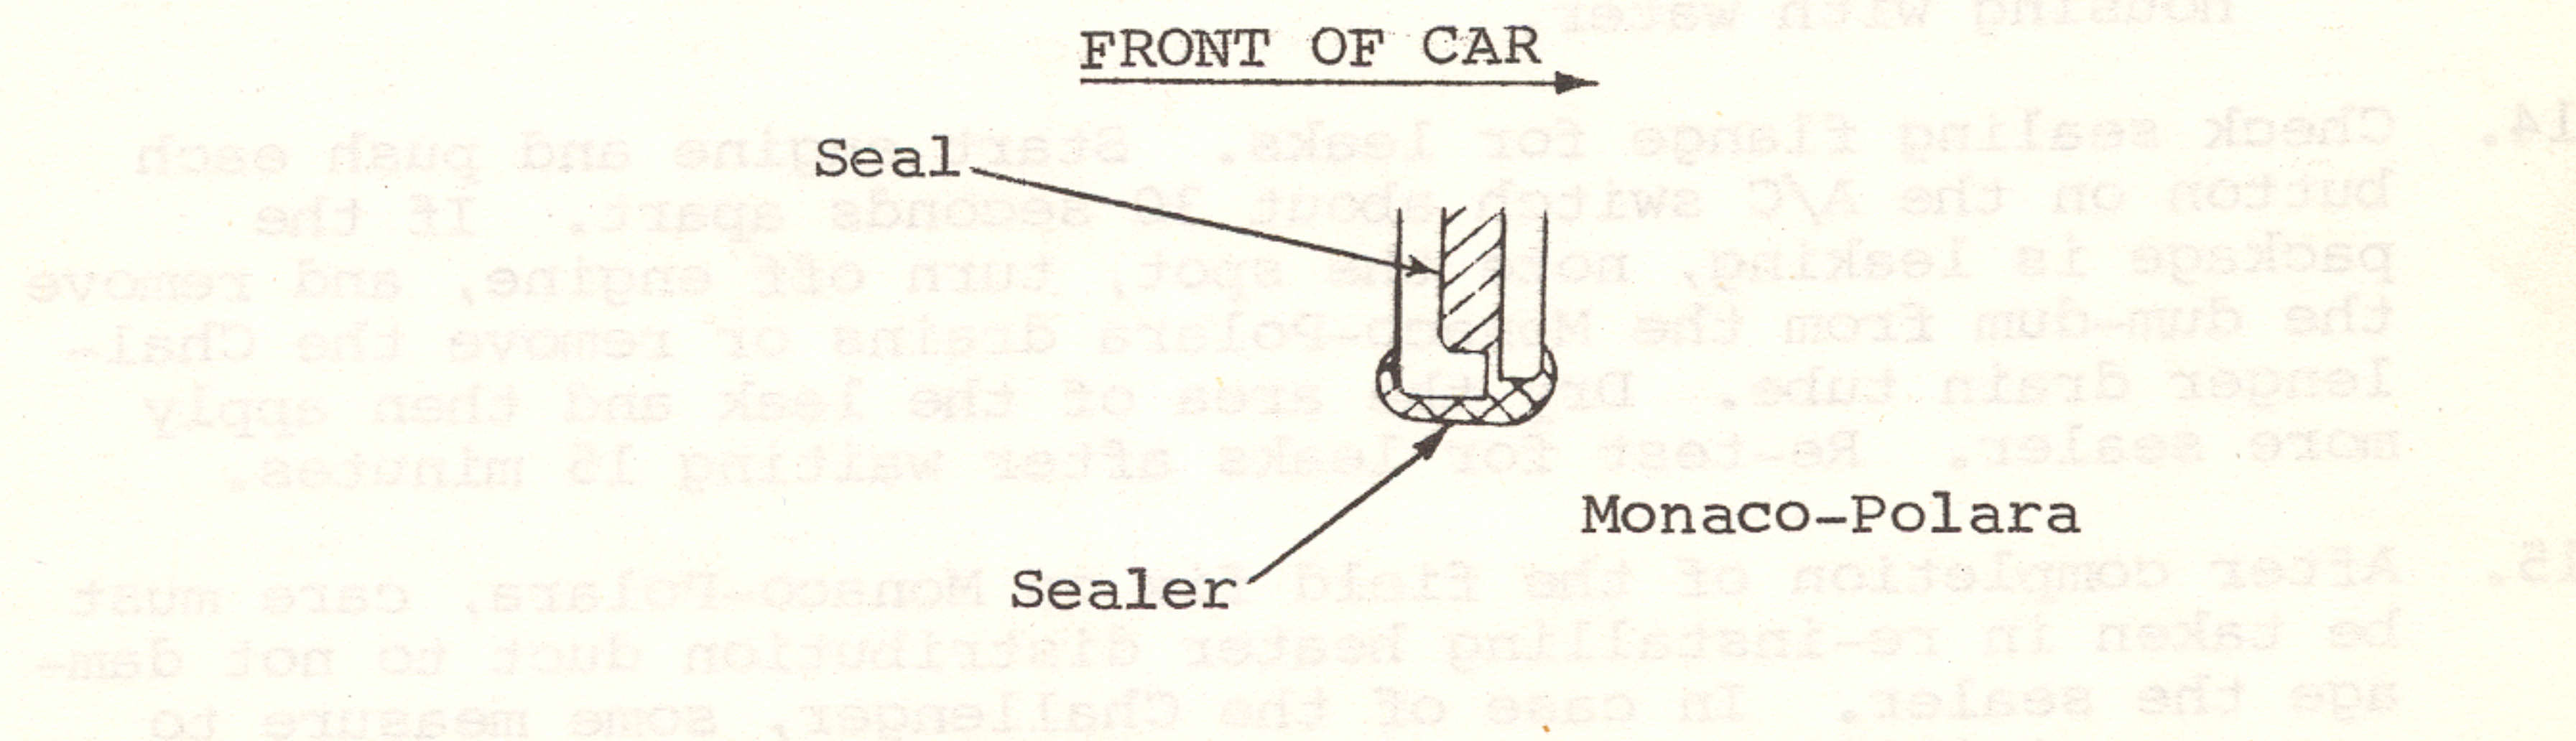
The following is a sketch of a good application of the sealer:

8. Dab the bottom edge of the flange with paper toweling and then inspect the towel for water marks. Re-dry if necessary.
9. Squeeze out a portion of the sealer on a plate and then apply with a soft, clean acid brush. Apply generously, stroking parallel to the flange.

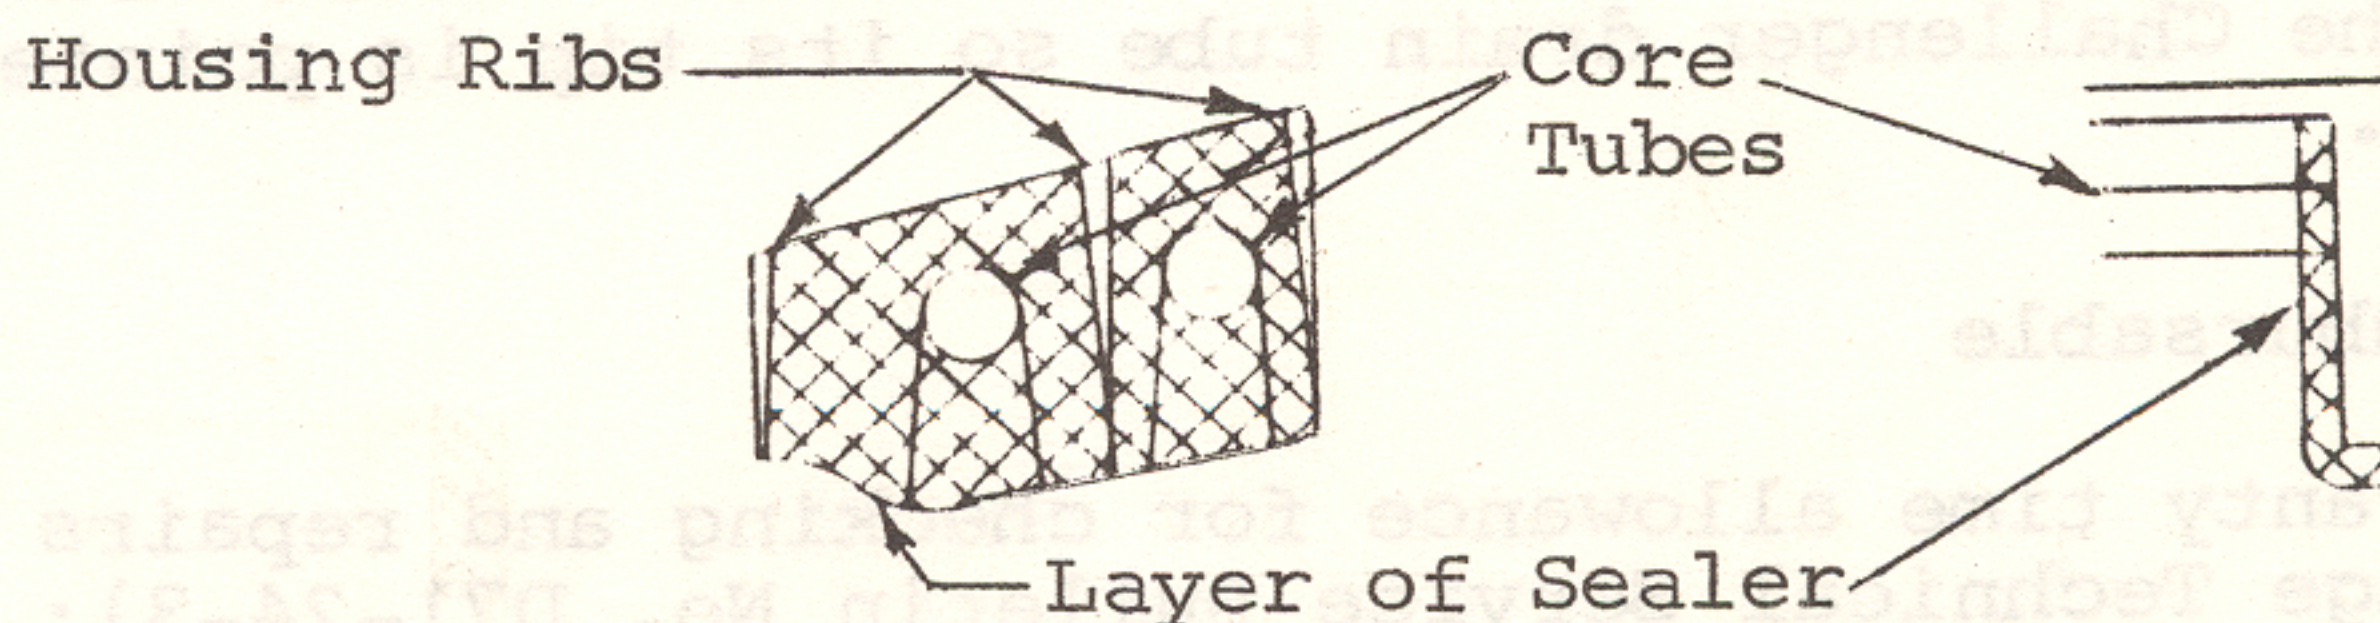
10. Particular attention should be paid to the heater core tube area on the Monaco-Polara. See below:

Apply additional sealer brushing it thoroughly into the heater core tube area on the right side covering as far around the tubes as possible.

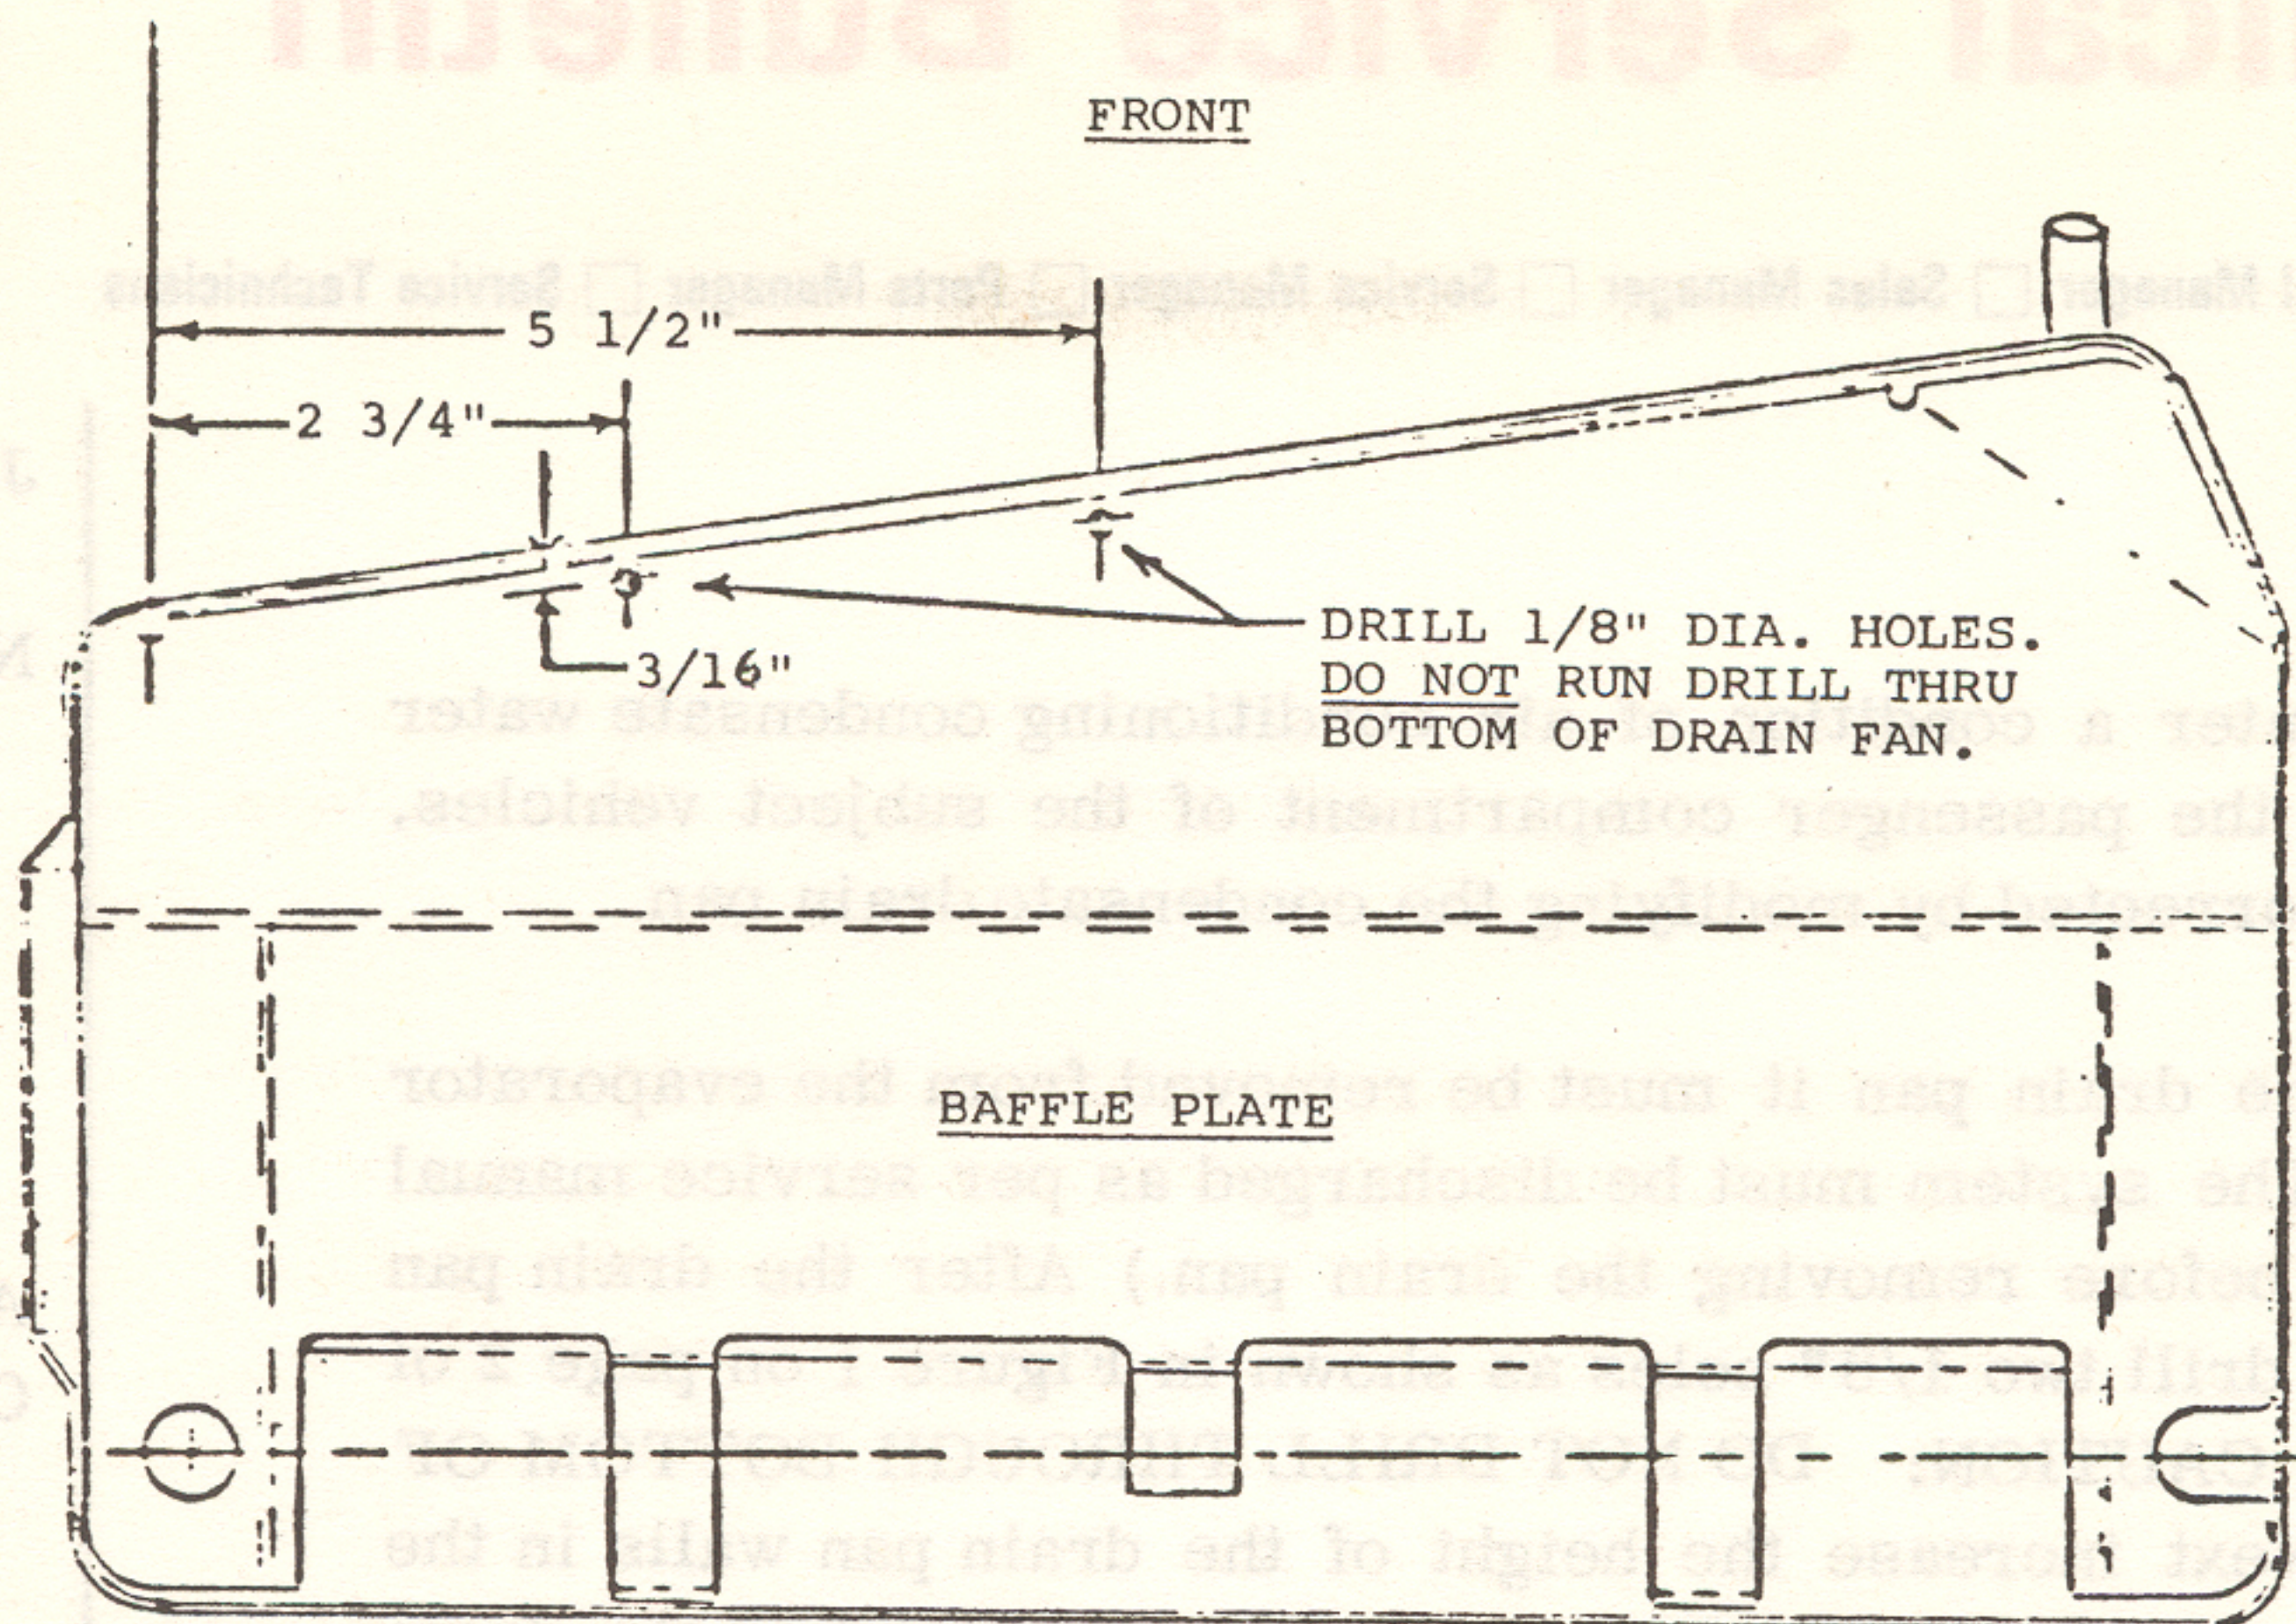
FIGURE 1

AIR CONDITIONING EVAPORATOR DRAIN PAN

To modify the drain pan it must be removed from the evaporator assembly. (The system must be discharged as per service manual instructions before removing the drain pan.) After the drain pan is removed, drill two 1/8" holes as shown in Figure 1 on page 2 of this bulletin. CAUTION: DO NOT DRILL THROUGH BOTTOM OF THE PAN. Next increase the height of the drain pan walls in the areas shown in Figure 2. Use a comparable material as the drain pan itself. Solder completely along the attaching edge for strength and to prevent possible leakage. Reassemble the unit and recharge as per service manual instructions.

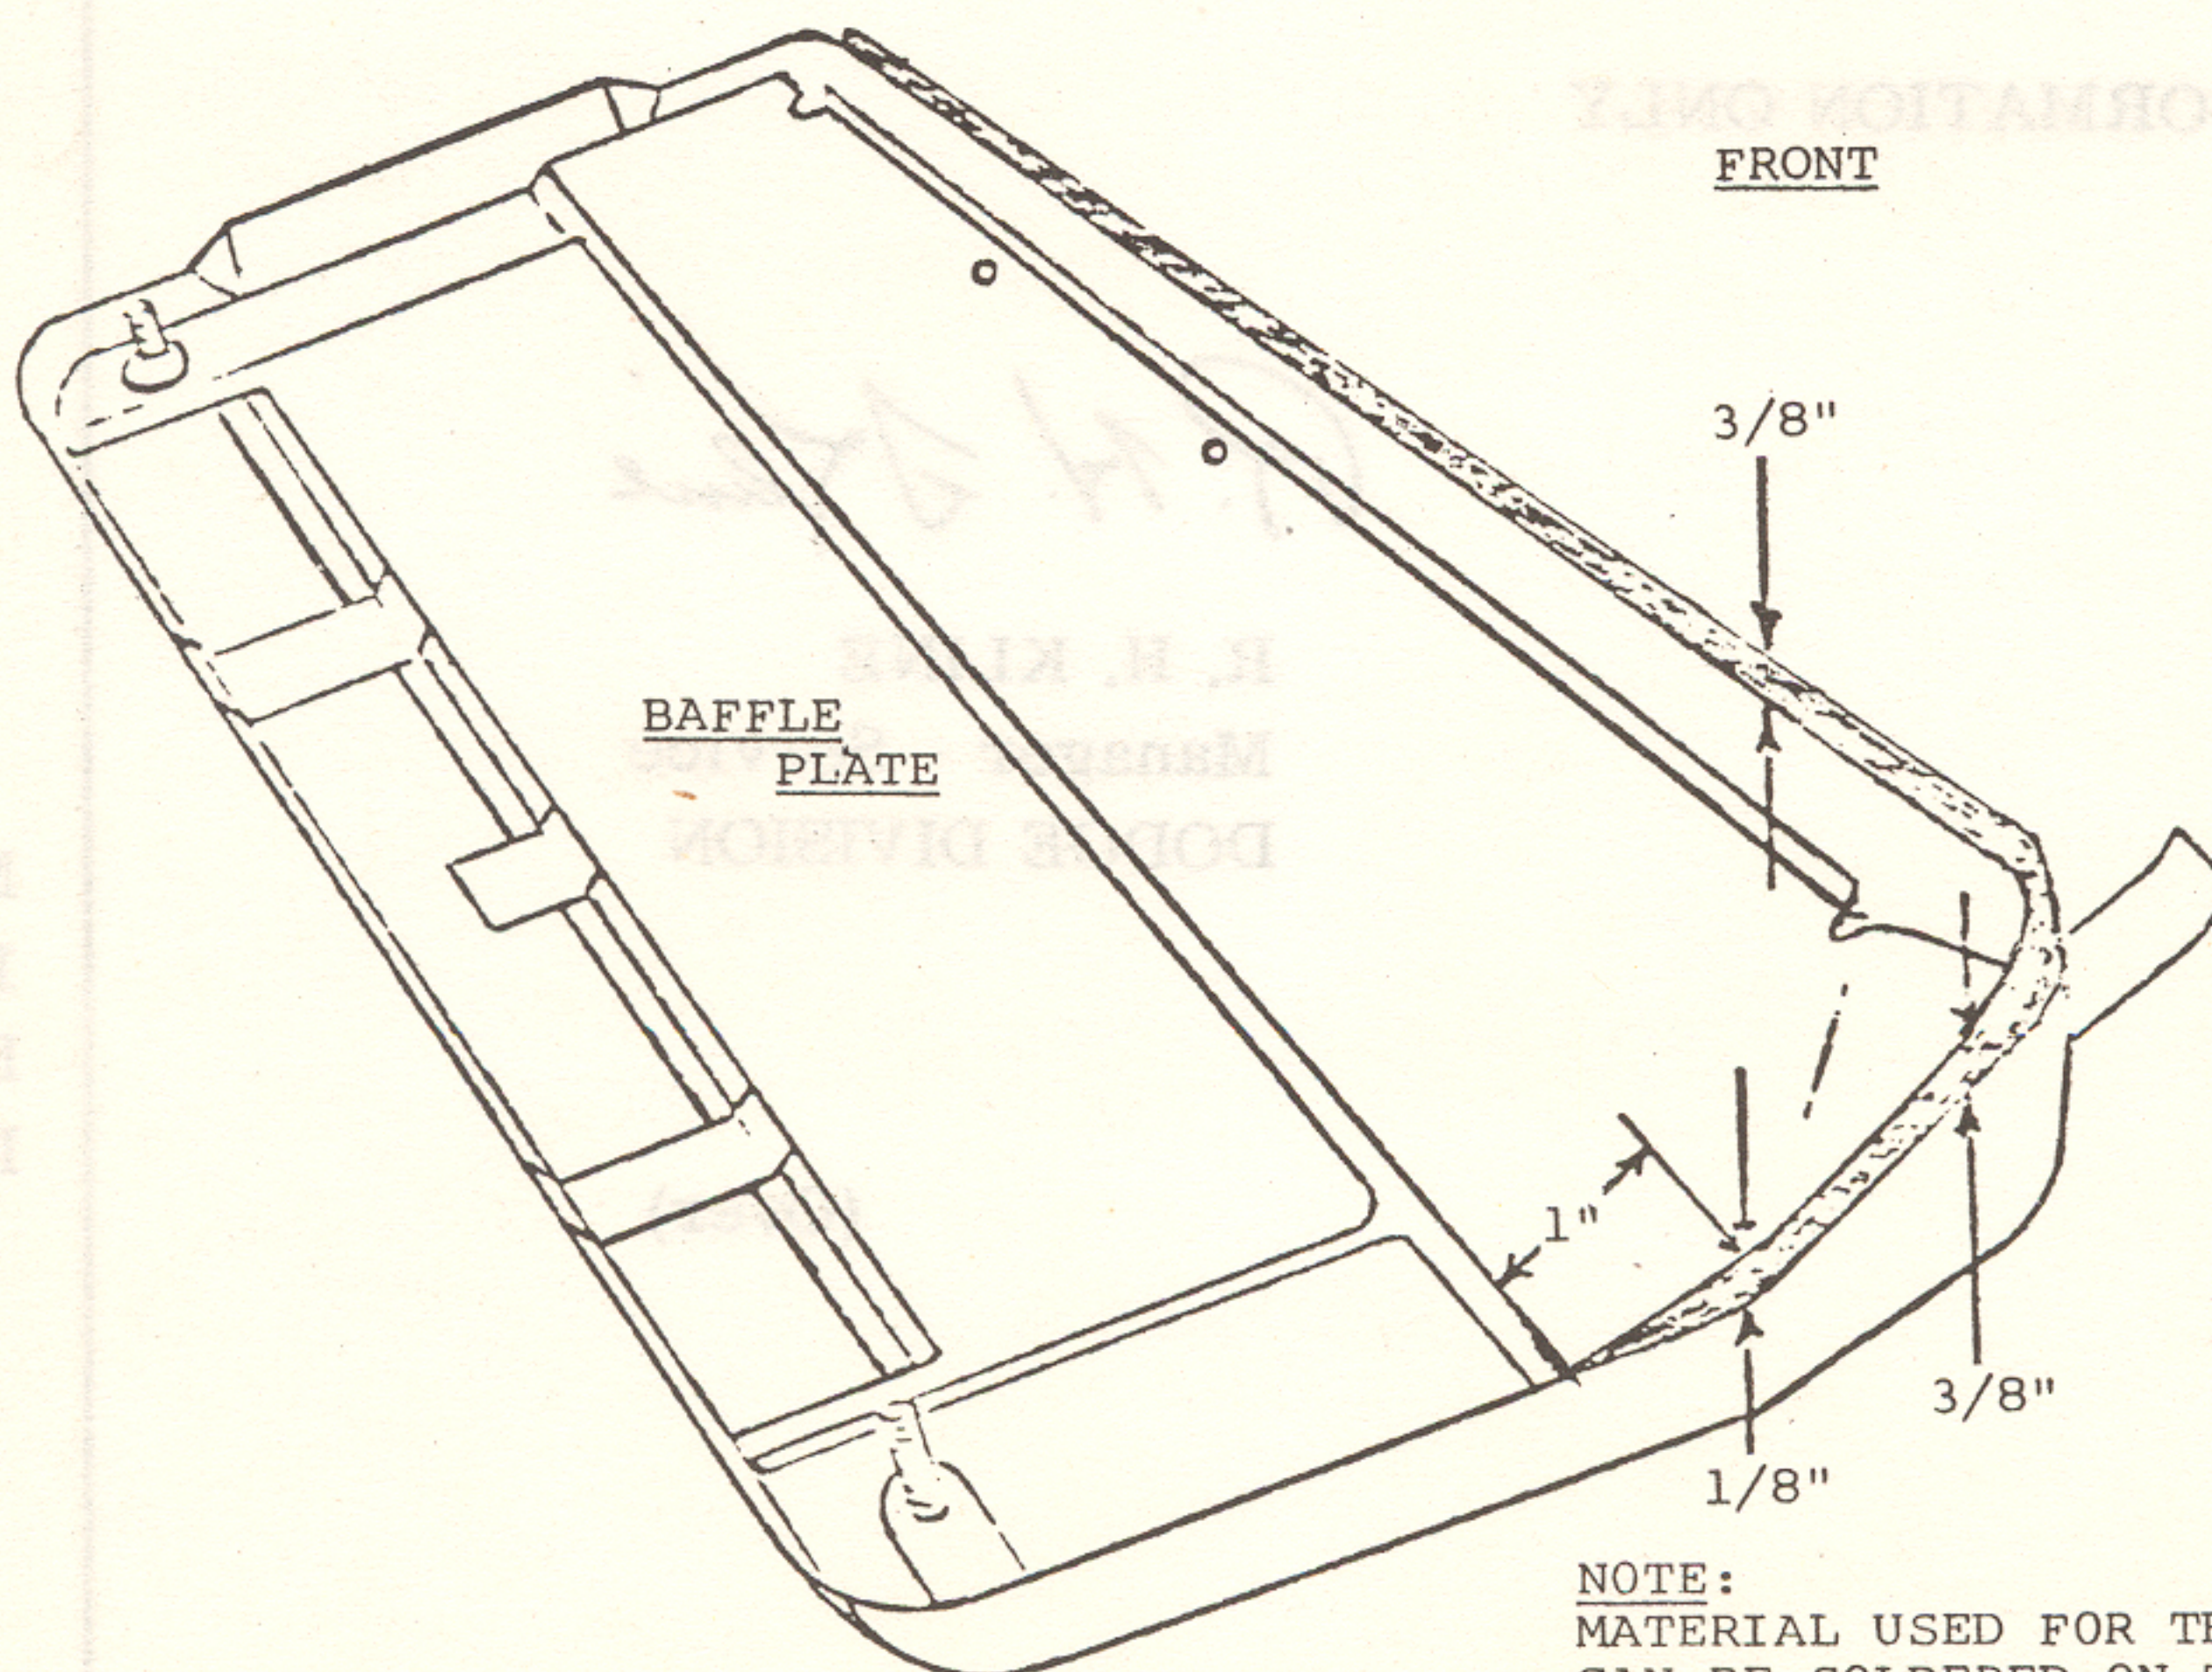
FIGURE 2

AIR CONDITIONING EVAPORATOR DRAIN PAN

NOTE:
MATERIAL USED FOR THE MODIFICATION
CAN BE SOLDERED ON THE INSIDE EDGE
OF THE DRAIN PAN

THE SHADED AREA INDICATES THE WALL
HEIGHT INCREASE

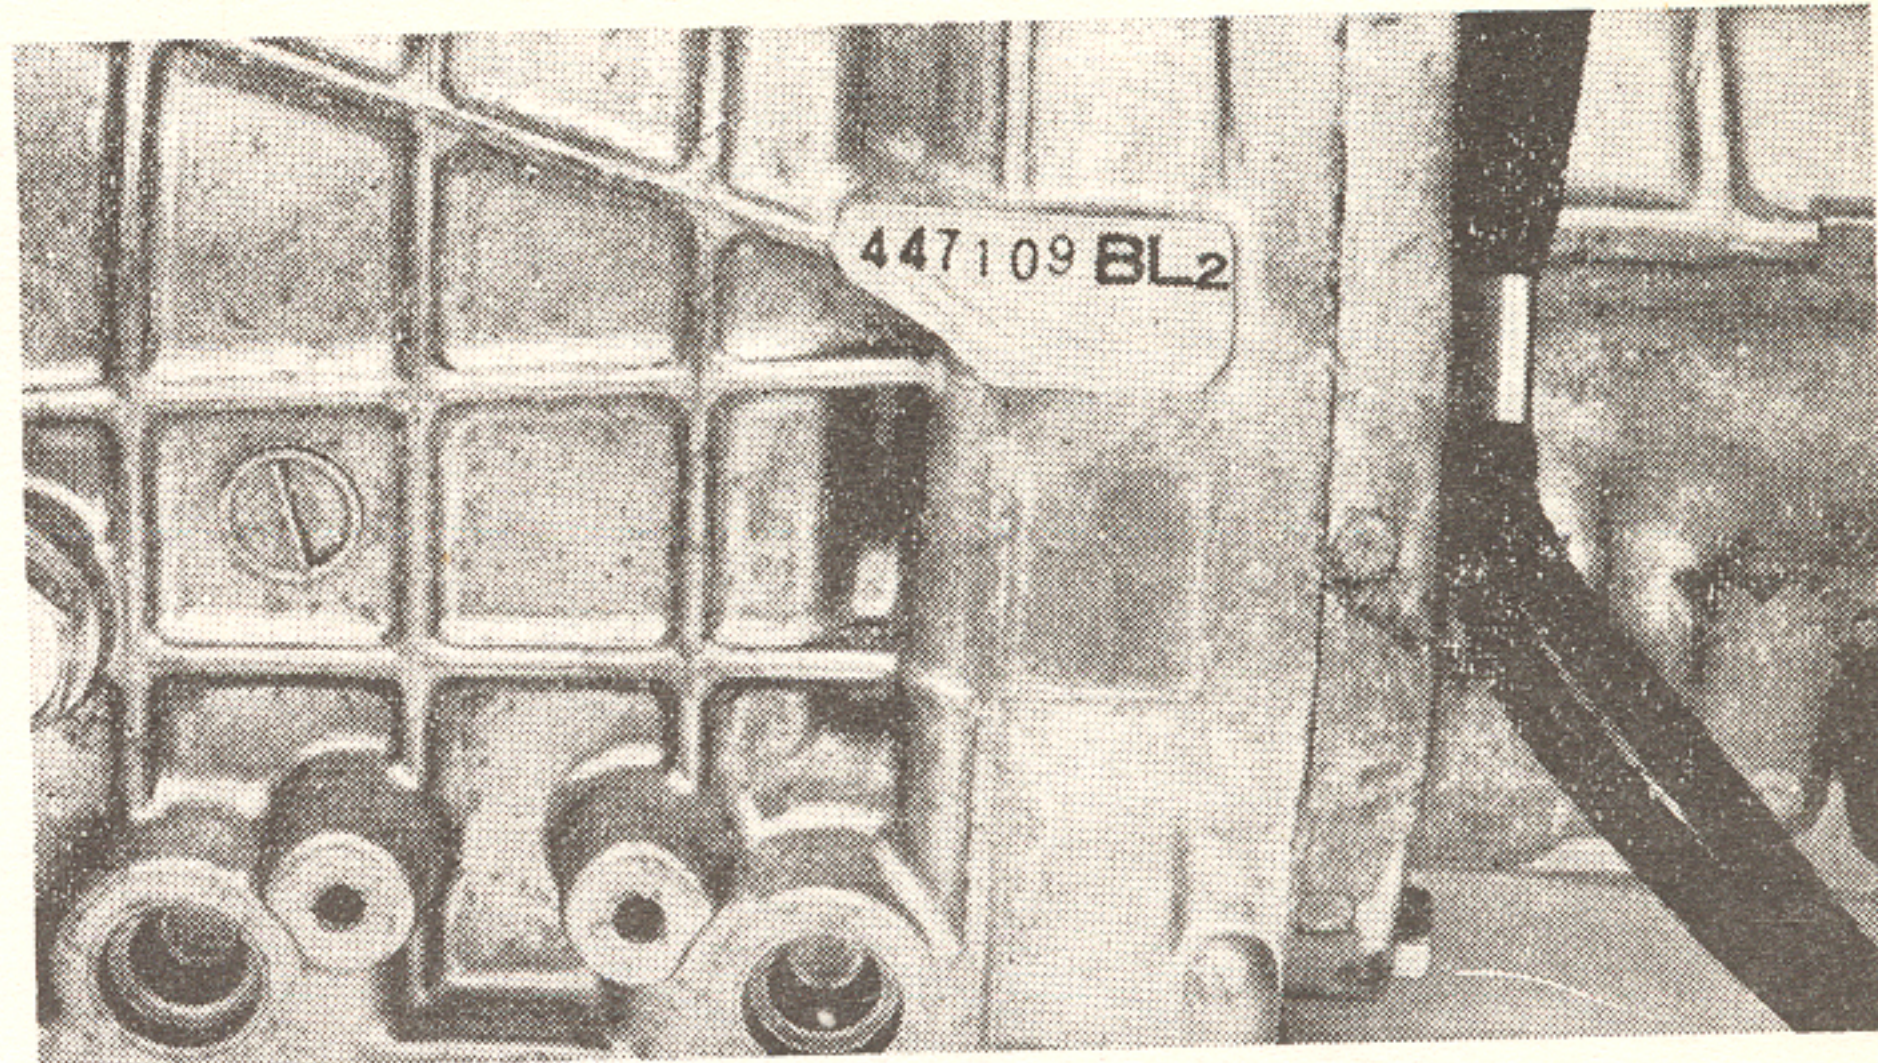
The transmission serial number is stamped on the left-hand side of the transmission case. (Figure 4)

Fig. 4 Transmission Serial Number

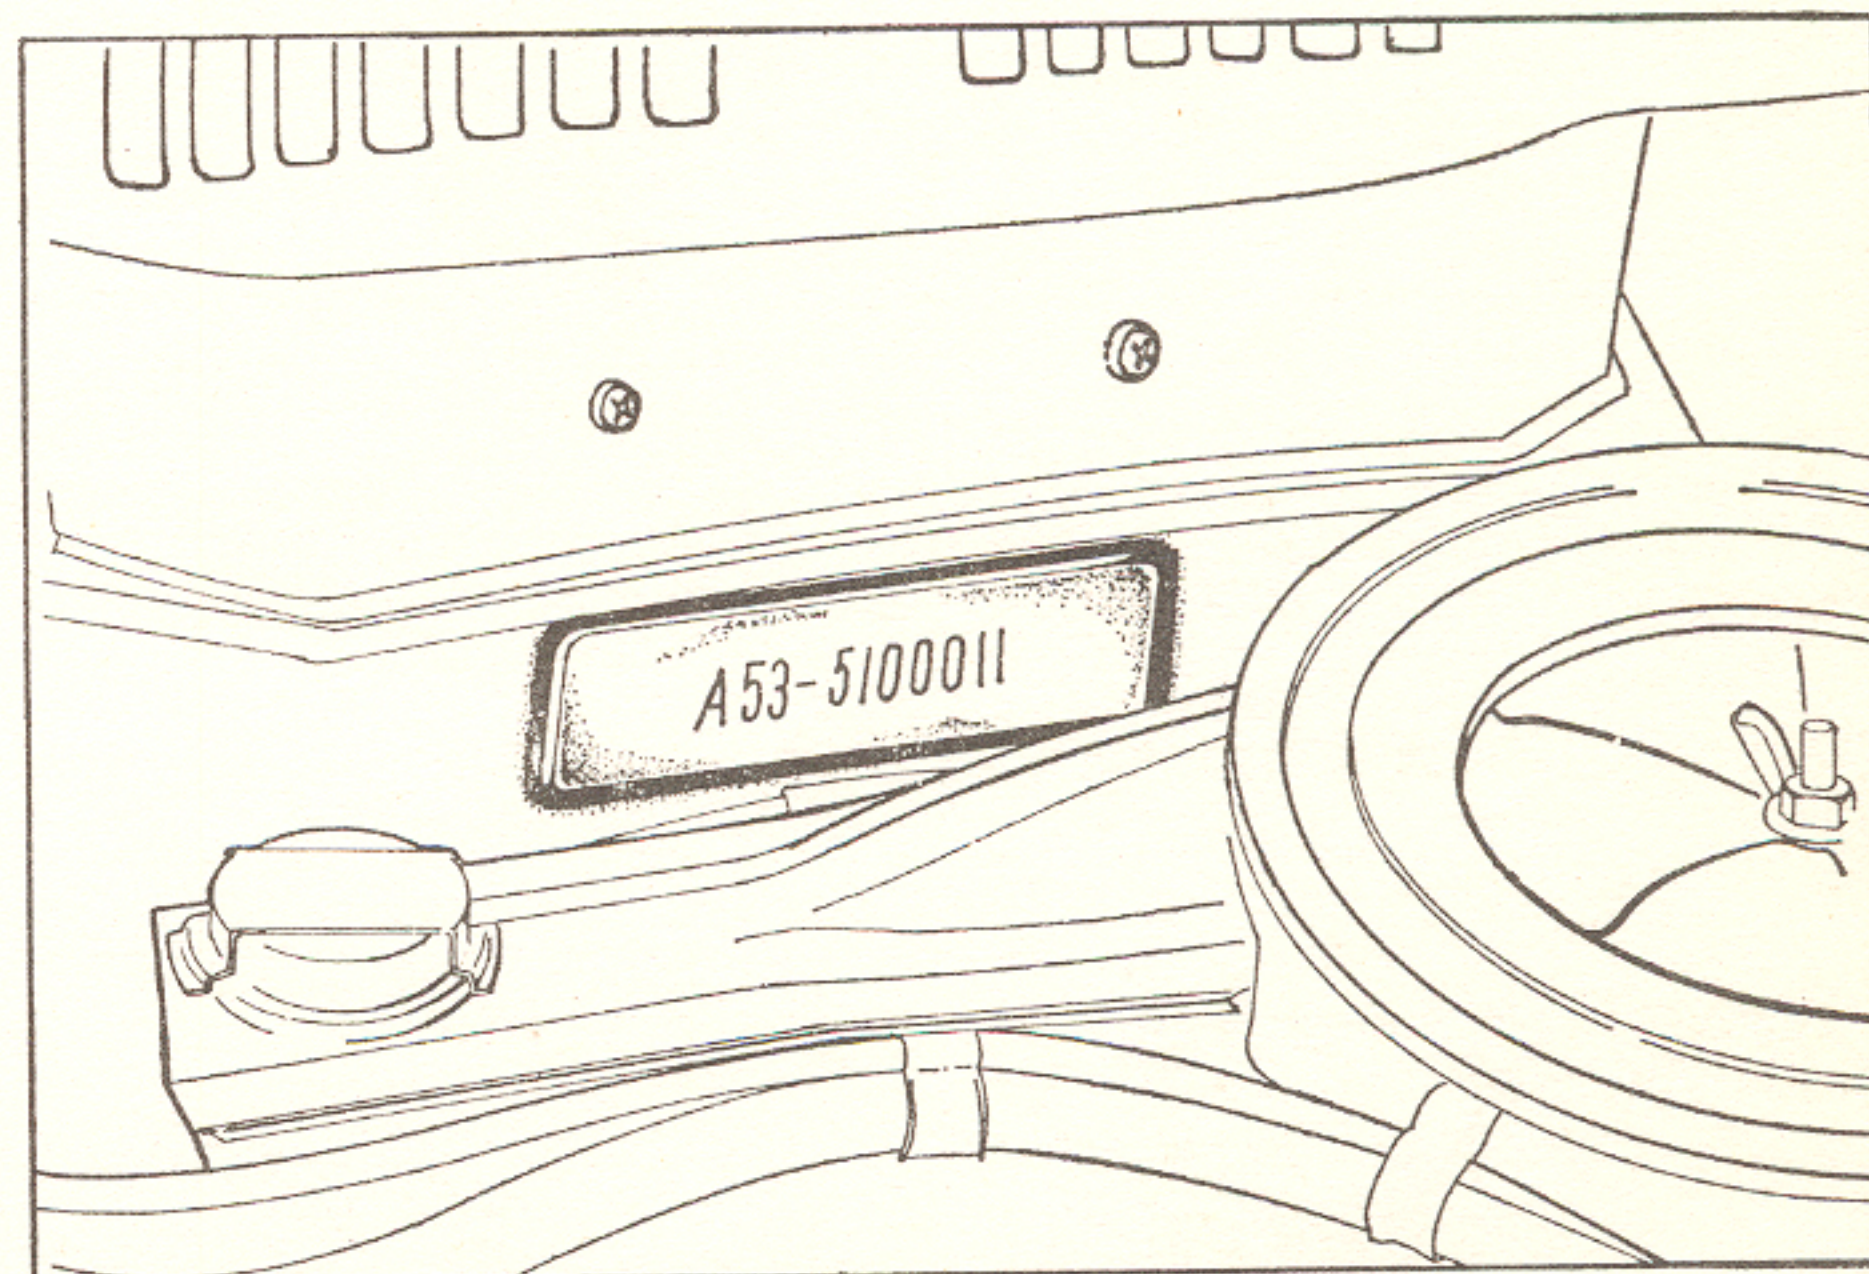
The body number is stamped on the top center of the fire wall located inside the engine compartment. (Figure 5)

Fig. 5 Body Number
