# **Technical Service Bulletin**

*	No. 21-07-73C
The information included in this Bulletin will update you on all major changes affecting the <b>1966</b> through <b>1973</b> TorqueFlite Transmission. It is also a quick reference guide for any interchangeability that was taken during the above model years.	MAJOR CHANGES AFFECTING FIELD SERVICE 1966 THROUGH 1973
We suggest you refer to this Booklet whenever you encounter a trans- mission failure.

Cricket/Imperial/Chrysler/Fury/Satellite/Valiant

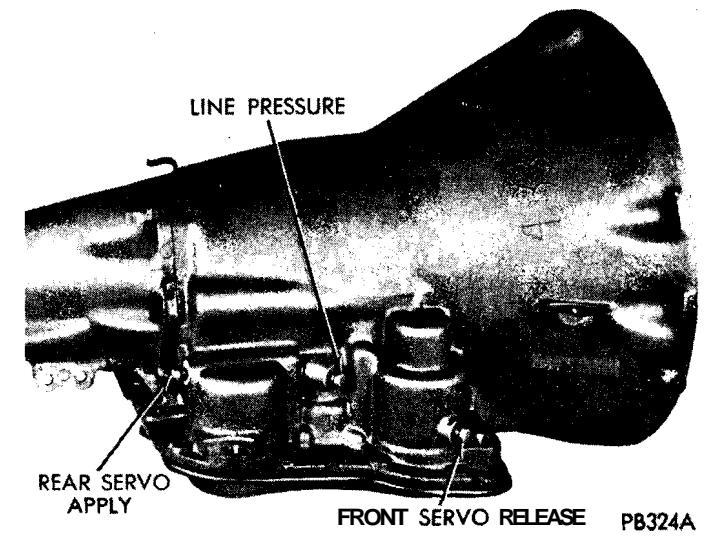
Fig. 1 – Pressure Test Locations (Right Side of Case)

(6) Rear servo pressure should read the same as line pressure within 3 psi.

(7) This tests pump output, pressure regulation, and condition of rear clutch and rear servo hydraulic circuits.

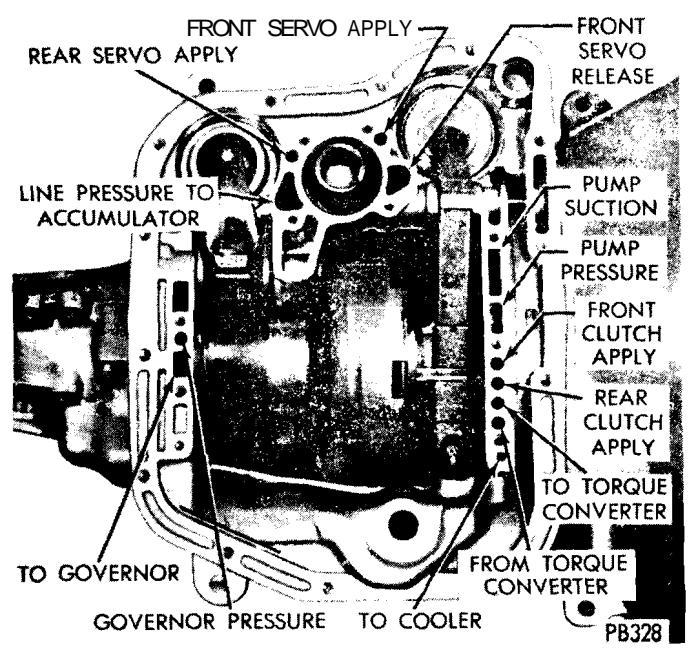
Fig. **3** – Air Pressure Tests

A "NO DRIVE" condition might exist even with correct fluid pressure, because of inoperative clutches or bands. The inoperative units, clutches, bands and servos can be located through a series of tests by substituting air pressure for fluid pressure (Fig. 3).

Direct air pressure into front servo "apply" passage. Operation of servo is indicated by a tightening of front band. Spring tension on servo piston should release the band.

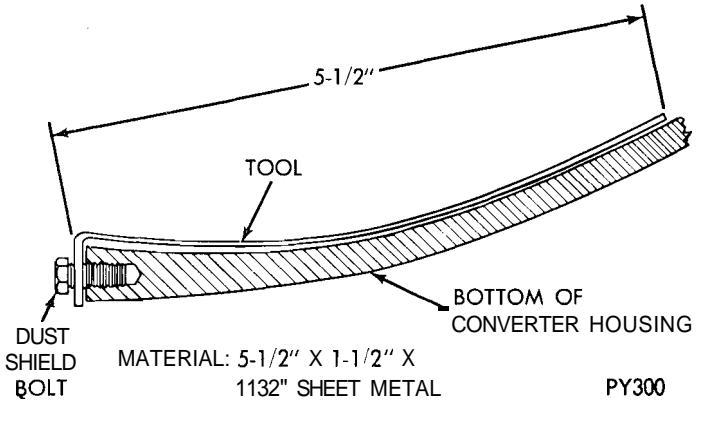
Fig. 4 – Leak Locating Test Probe Tool

(3) Fabricate and fasten test probe (Fig. 4) securely to convenient dust shield bolt hole. Make certain converter is cleared by test probe. Tool must be clean and dry.

(6) If upper surface of test probe is dry, there is no converter leak. A path of fluid across probe indicates a converter leak. Oil leaking under the probe is coming from the transmission converter area (Fig. 5).

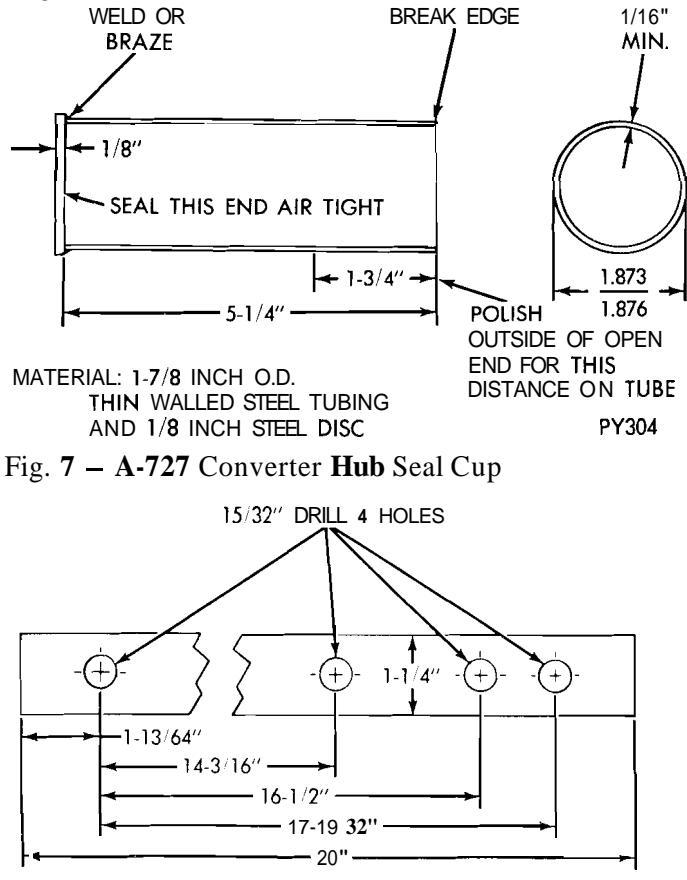
Fig. 8 – Hub Seal Cup Retaining Strap

(3) With rotary motion, install converter hub seal cup over input shaft, and through the converter hub seal until the cup bottoms against the pump rotor lugs. Secure with cup retainer strap (Fig. 8), using converter housing to engine block retaining bolts.

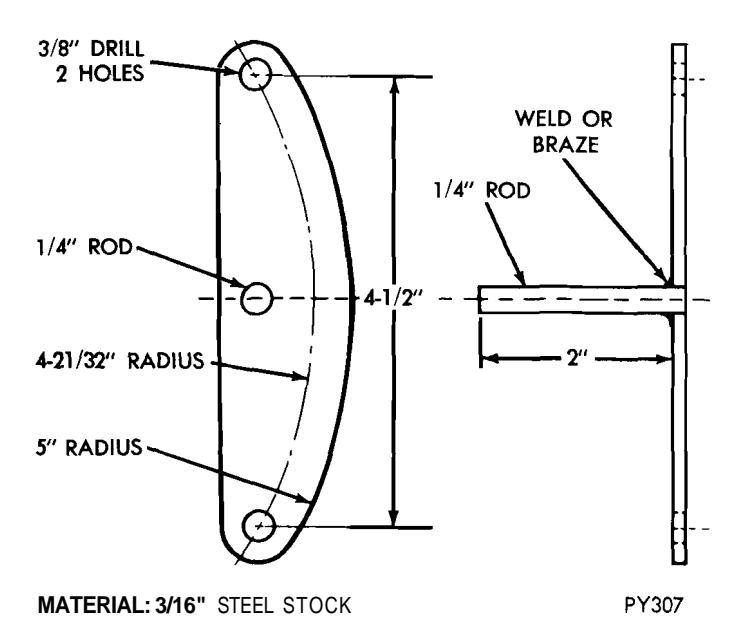
Fig. 9 – A-727 Vent Plug Retainer

(2) Remove necessary front pump housing bolts, and vent shield. Install vent plug (rubber stopper), and vent plug retainer preferably using longer bolts than those removed.

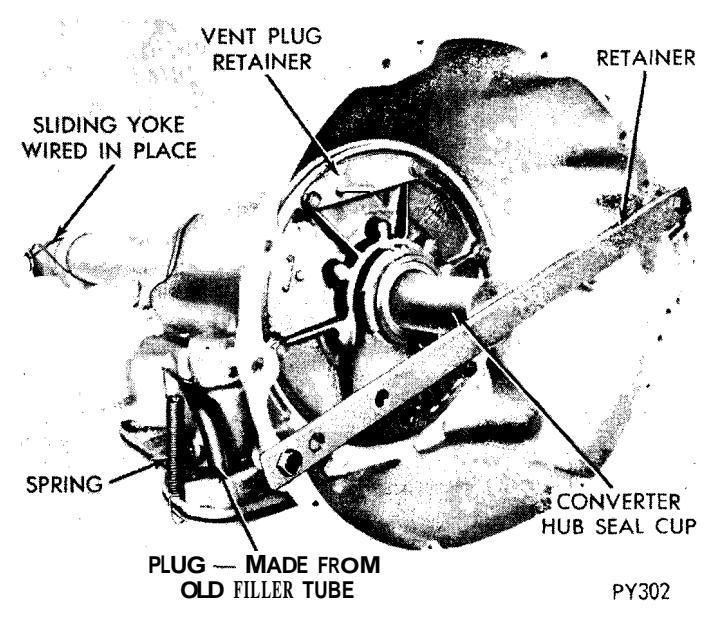
**Fig. 10 – Transmission Prepared for Test**

(1) Install filler tube bore plug, propeller shaft yoke (tie in with cord or wire), flared tube fitting cap (on front cooler line fitting), and pipe nipple (in case at rear cooler line fitting) (Fig. 10 and 11).

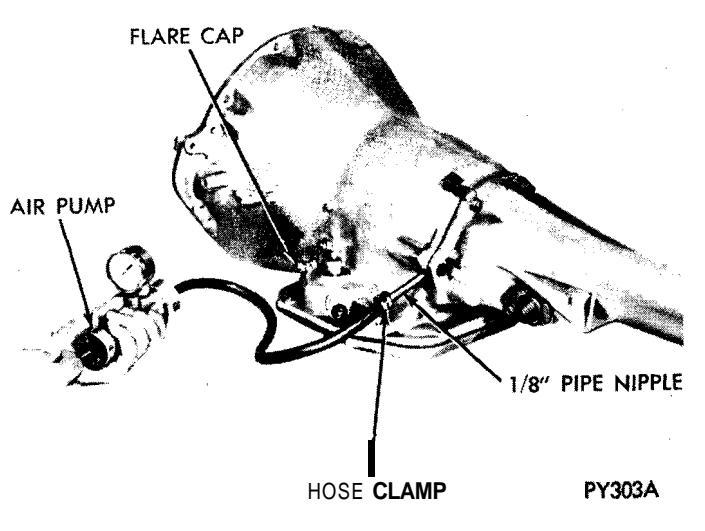
Fig. 11 – Pressurizing Transmission

(4) Attach and clamp hose from nozzle of Tool C-4080 to pipe nipple, which is in the rear cooler line fitting position in case (Fig. 11).
